**2-56A AND 58-108A REGINA ROAD, CROYDON
CONDITION SURVEY REPORT
MECHANICAL, ELECTRICAL AND PUBLIC HEALTH
SERVICES**

**5015598-RDG-XX-XX-DOC-ME-CSR
REVISION 2**

CROYDON COUNCIL

24th September 2021

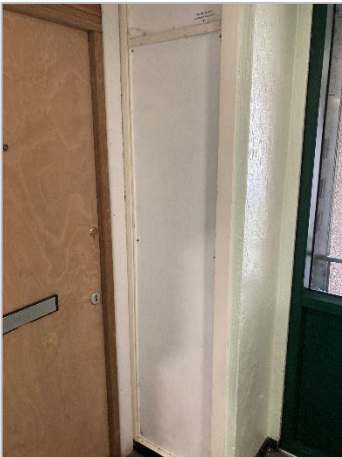
We assume that each of the apartments has an electrical meter and consumer unit cupboard immediately adjacent to the front door accessed from the lift lobby. However, these doors have been replaced with screwed shut panels making access almost impossible.

Photo 5 Apartment electrical cupboards have been sealed shut

If the apartment meters and consumer units are located in the cupboards outside each apartment (as in the previous Regina Hose building visited), the panels should be replaced with full height lockable doors.

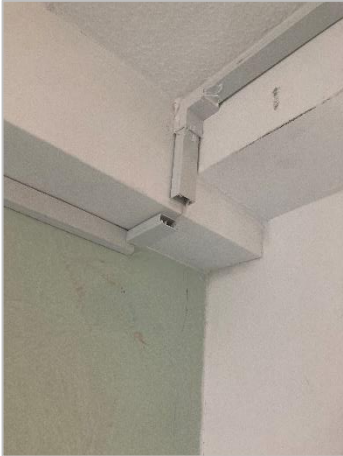
The sensors appeared quite new and in good condition although the retrofit nature of the installation has meant that sections of the mini trunking are prone to damage, both accidental and malicious.

Photo 7 Damaged smoke cable trunking

Some of the mini-trunkings need attention where covers are missing:

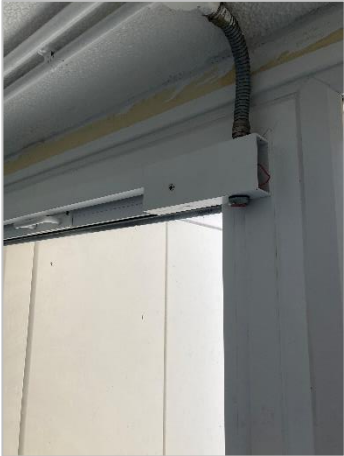
We did notice the cover missing from the actuator on the 10th floor of 2 to 56A.

Photo 8 AOV actuator cover missing

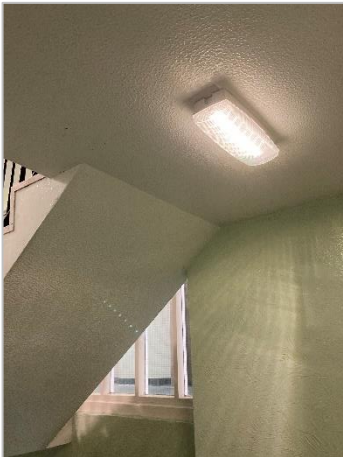
The newer emergency fittings were in good condition. The older ceiling mounted fluorescent fittings were quite dated and could do with replacing as part of a general decorative uplift.

Photo 11 Older style staircase light

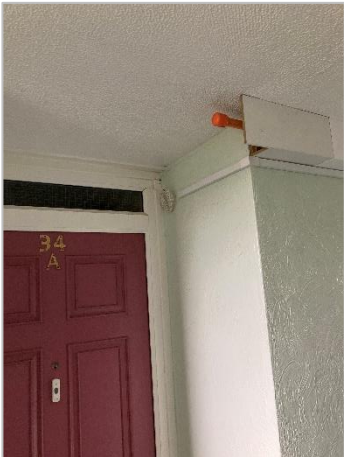
The following apartments do not appear to have been connected up to the residential sprinkler system, the branches to supply them appear to be capped off at high level. The fire strategy for the building needs to be reevaluated given that sprinklers have not been provided throughout the apartment. We strongly recommend these apartments be fitted to the system.

Photo 12 Flat 34A not connected to sprinkler system?

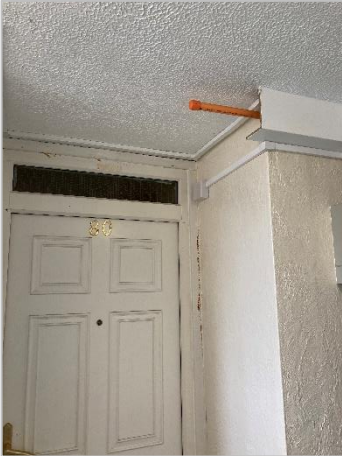
Photo 13 Flat 80 not connected to sprinkler system?

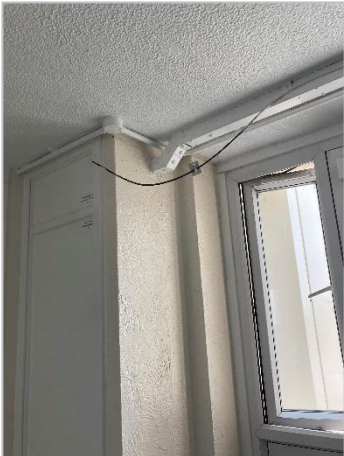
Photo 16 Some loose cabling

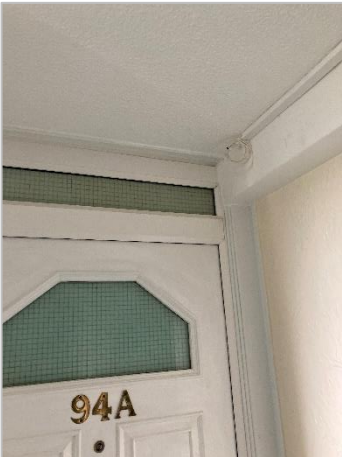
Photo 17 Some loose cabling

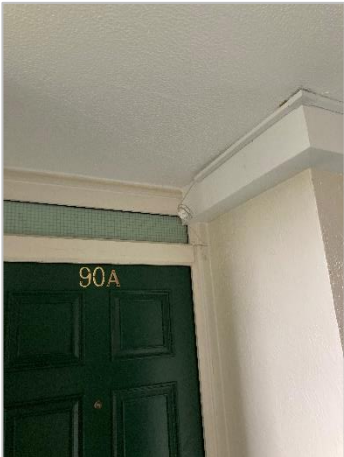
Photo 18 Some loose cabling

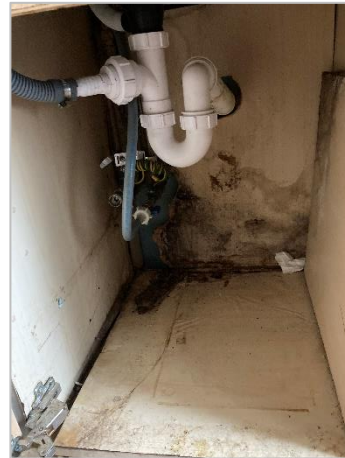
Photo 20 Evidence of leak under sink (28A)

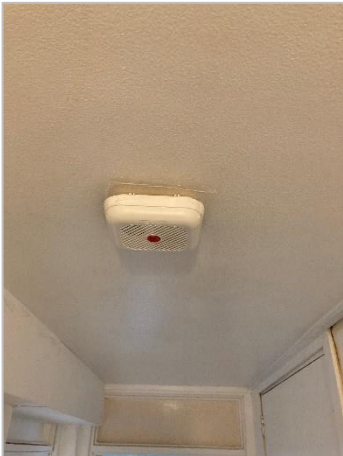
Photo 31 Older smoke detector

- Smoke detector for Flat 90A missing.
- Fire strategy should be determined defining if heat detection should be included in the kitchen and any further smoke detectors required in the apartment.
- Smoke heat detectors should be replaced with hard wired type and consideration of CO2 sensing.

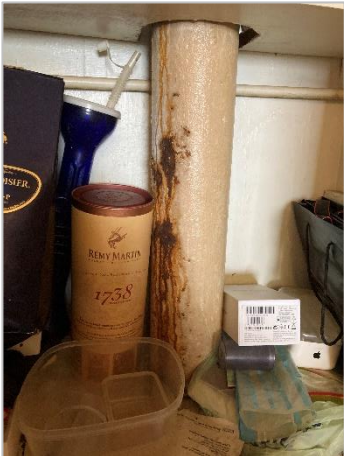
Foul and waste water drainage is provided locally to the sanitary ware behind the bath/shower as required. The stacks may be cast iron but are not wholly visible for survey however we did note a stack leaking in Flat 90A

Photo 34 Apartment 90A leaking soil stack

- The cold water system risers should be traced and drawn schematically – they should also be replaced.
- Each flat should be provided with a clearly labelled point of emergency isolation of the water supply.
- The hot and cold water pipework network in the apartment should be replaced and redundant systems removed.
- Consideration of replacing the soil stacks and above ground plumbing should be given due to age of the installation.

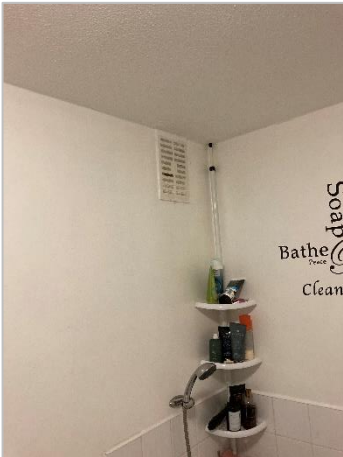
All of the ventilation equipment is in poor condition with some grilles blocked – this will contribute to the general mould issues in the apartments. Consideration should be given to modernising the ventilation system, perhaps to a heat recovery system, as part of an extensive refurbishment to reduce running costs. Windows and trickle vents all need to be cleaned and maintained

Photo 35 Poor bathroom extract ventilation

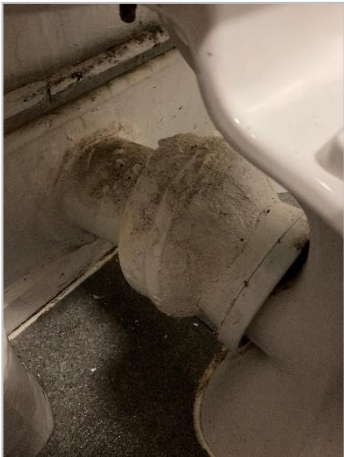
Most of the vertical soil stacks are not visible and are boxed in behind the bath/shower although we did see one that showed signs of surface corrosion probably from a leak.

Photo 36 Original cast iron drainage leaking

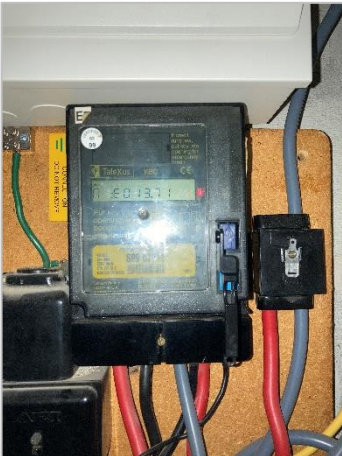
Photo 37 Unmodernised meter

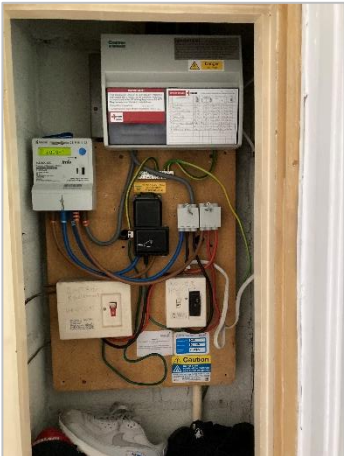
- Most of the flats have newer prepayment electrical meters and modern consumer units, however the extent to this work is not consistent – we found apartments with original electrical switchgear.

Photo 38 Unmodernised electrical equipment

- The extent of the rewiring and conditioning of the electrical equipment should be tested and consideration to a complete rewire as part of a full refurbishment.
