# Report Document

## Project: 43129

Project Name: Regina Road 1-87  
Project Address: Regina Road  
London  
SE25 4TW

## Roof Survey Report & Recommendations

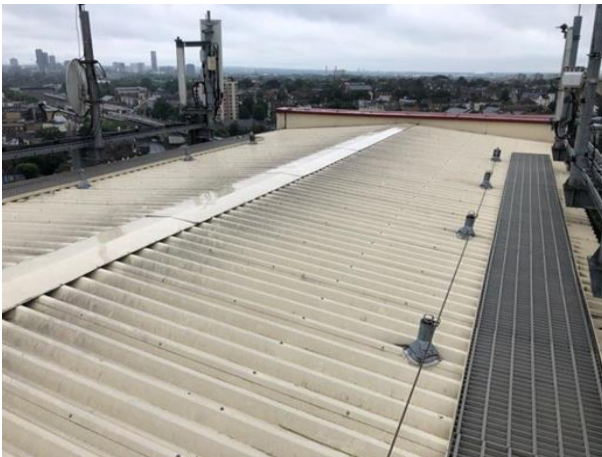
##### Main Roof Area - Description

Image of main field area with access walkway platform.

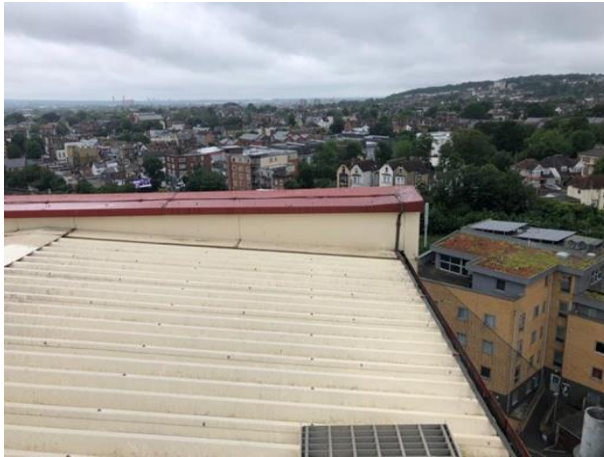
**Main Roof Area - Description**

Parapet wall with metal cappings.

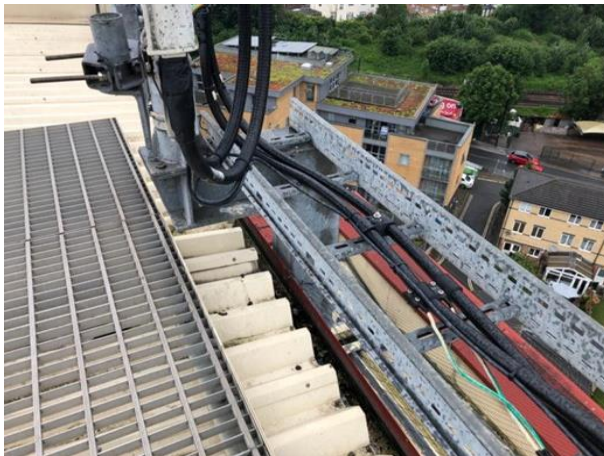
**Perimeters - Description**

Roof falls towards the perimeter edge which is finished with a metal external gutter discharging into downpipes.

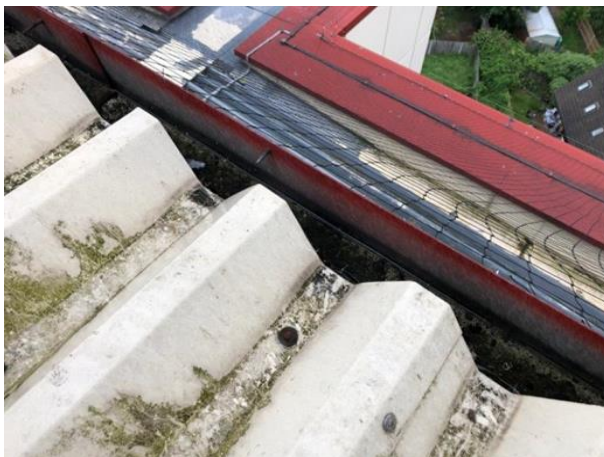
**Perimeters - Description**

Additional image of external gutter metal box gutter to perimeter edge.

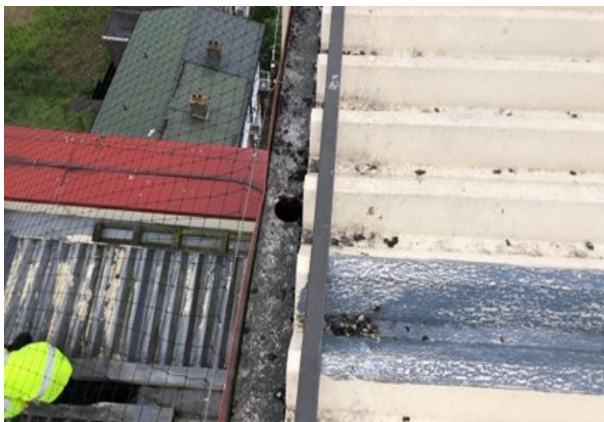
#### Perimeters - Description

Liquid repairs have been carried out in this area indicating a history of issues involving water ingress.

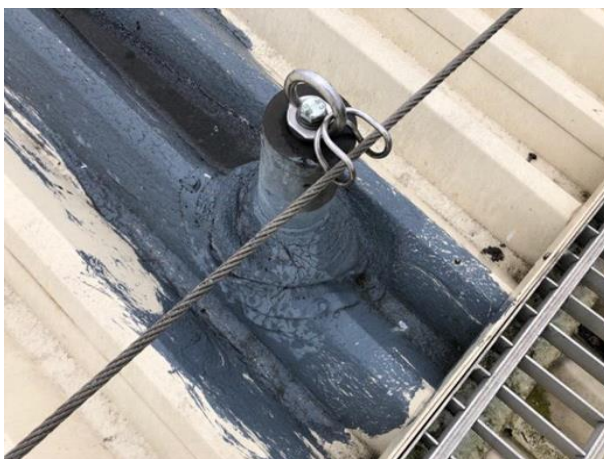
#### Penetrations - Description

Liquid repairs have been carried out to the base of the defective Mansafe posts.

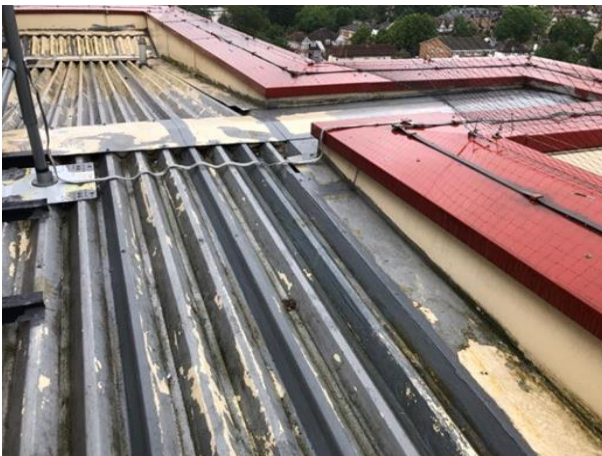
### Main Roof Area - Description

Image of main field area with parapet wall and metal cappings.

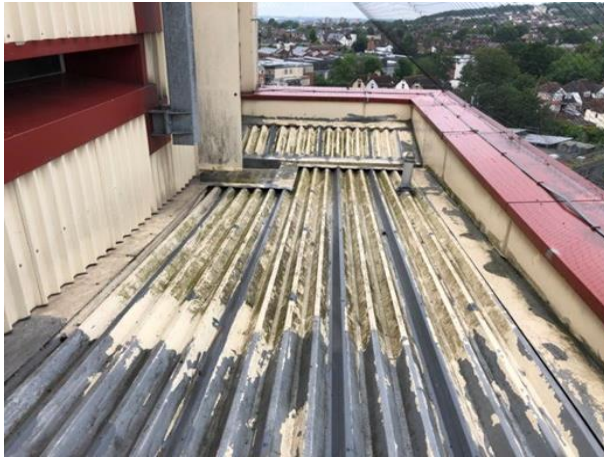
### Main Roof Area - Description

Additional image of main field area.

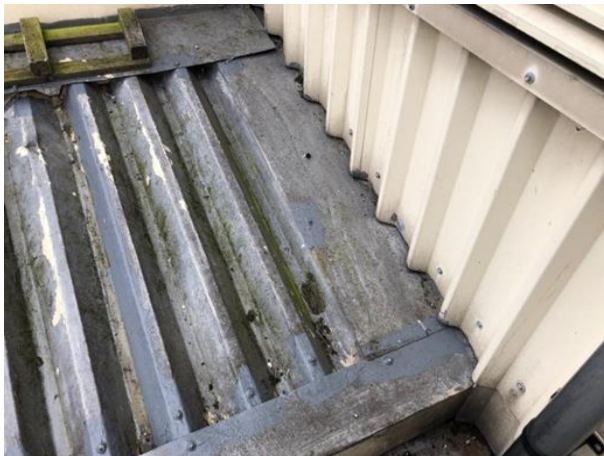
### Main Roof Area - Defects and Design Notes

Multiple liquid repairs have been carried out to defective areas.

As mentioned above, we recommend considerations are made to remove sections of the existing roof, mainly around the outlet locations in order to ascertain the condition of the areas below.

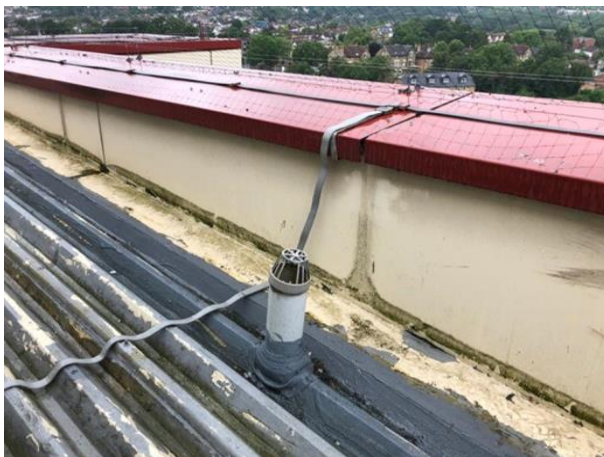
### Main Roof Area - Defects and Design Notes

Pipe penetration with liquid repairs

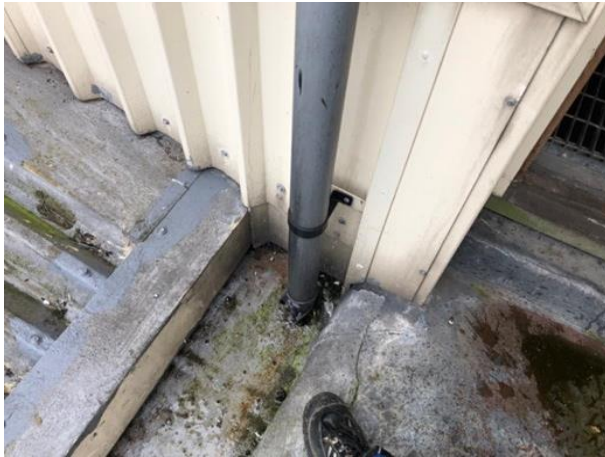
#### **Drainage Falls - Description**

Downpipes from higher roof level discharge into box valley gutters which drain into parapet chutes located within the cladding.

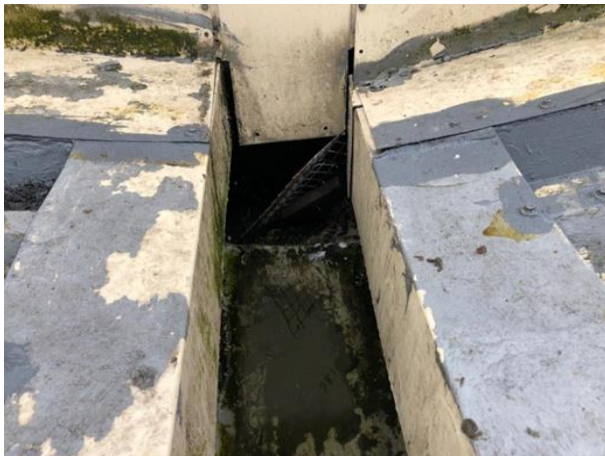
#### **Drainage Falls - Description**

**Defects:** Numerous liquid repairs have been carried out in this location and ponding water is evident due to blockages.
- **Parapets**  
**Details:** Parapet wall with metal cappings.

Falls within the box gutter are inadequate and a build up of ponding water was evident during the survey.

Due to the amount of repairs carried out in this area we would recommend that more intrusive inspections are carried out in this area.

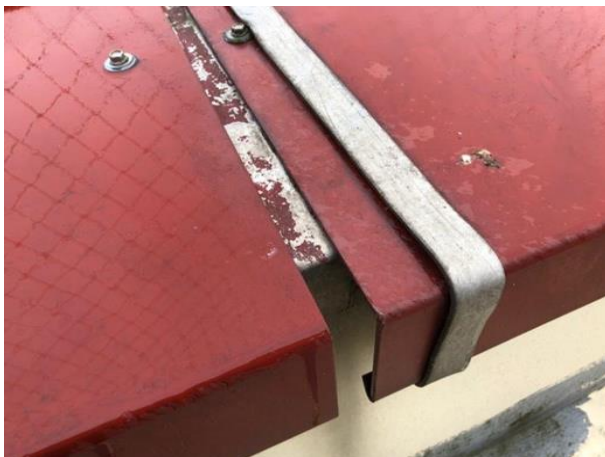
#### **Parapets - Defects and Design Notes**

**Defects:** Cappings appear loose with gaps within the profiles leaving the area beneath exposed to the elements.
- **Skirtings**  
**Details:** Upstand to higher roof level with wall mounted plant items.

Gaps within the metal cappings leave the area exposed to the elements.

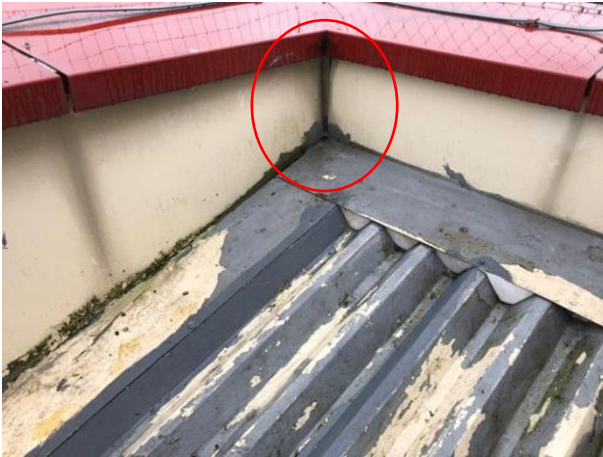
**Parapets - Defects and Design Notes**

Junction between the metal cladding to the parapet shows a gap that has been temporarily filled with a mastic sealant.

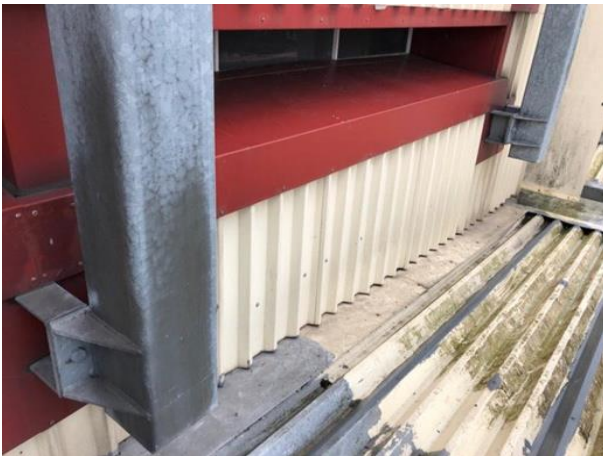
**Skirtings - Description**

Upstand to higher roof level.

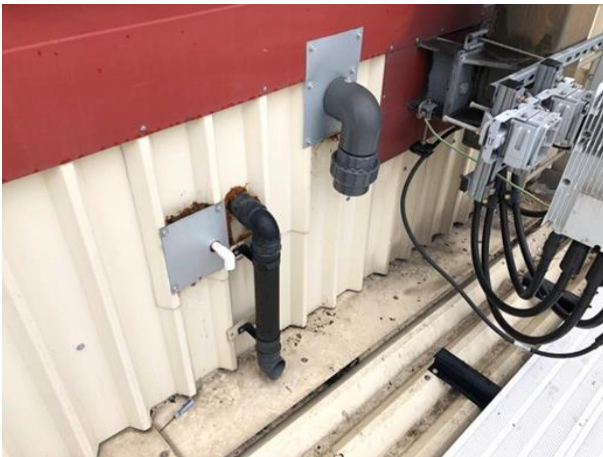
**Penetrations - Description**

Overflow and vent pipes penetrate the metal cladding to the upstand.

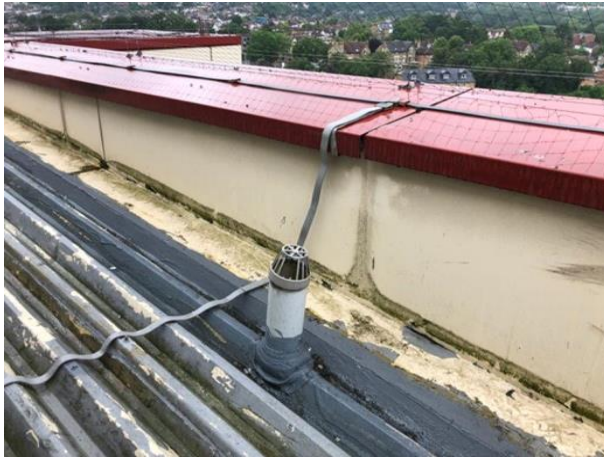
#### Penetrations - Description

- **Penetrations**  
**Details:** Vent and overflow pipes penetrating the main field area and upstand.  
**Defects:** Base of soil vent pipe has received liquid repairs in an attempt to prevent ingress via the defects.

Base of the soil vent pipes have received liquid repairs.

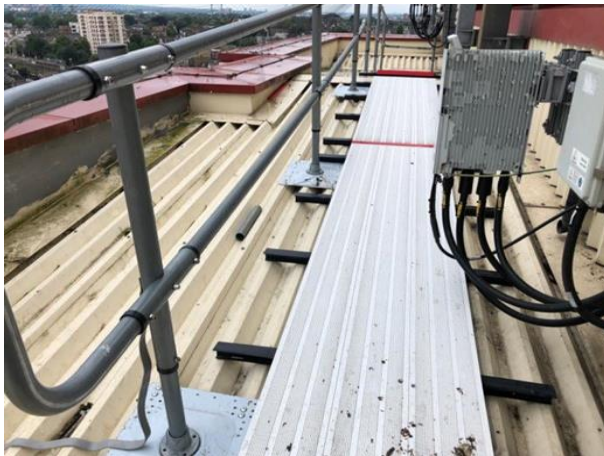
#### Handrails - Description

Metal platform has been fixed to existing structure to provide safe access for maintenance.

Wall mounted telecoms units are located in this area.

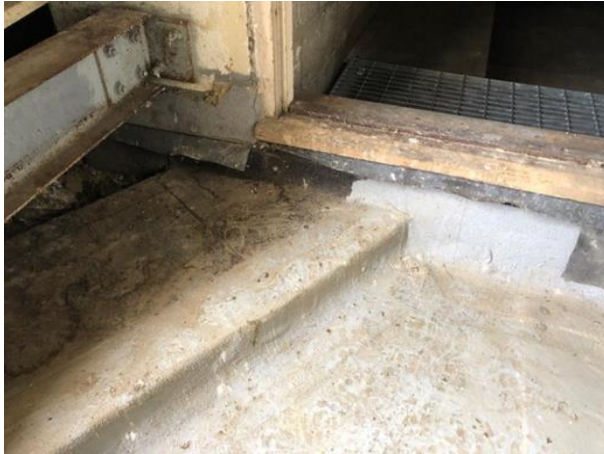
#### Main Roof Area - Description

Image of main field area with door threshold and evidence of previous repair works carried out using a liquid compound.

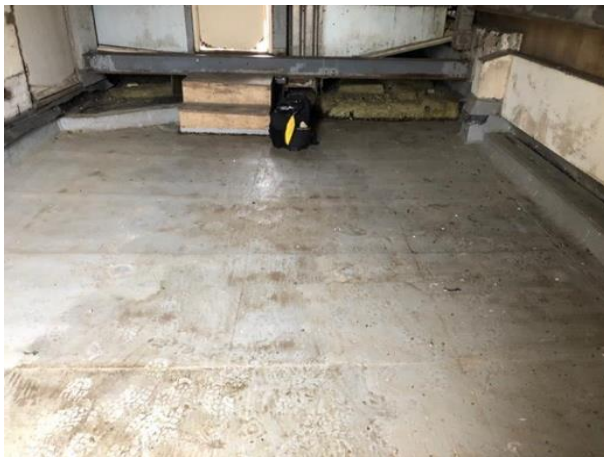
#### Main Roof Area - Description

Additional image of main field area.

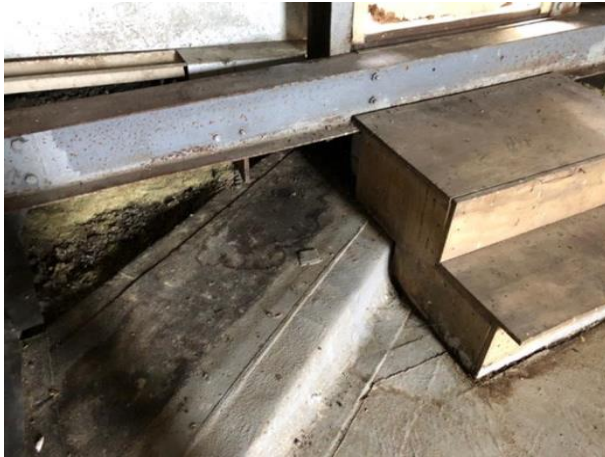
#### **Main Roof Area - Description**

Steel beams used to support the profiled metal structure have been fixed to the original parapet wall.

Wooden steps used to provide access for maintenance.

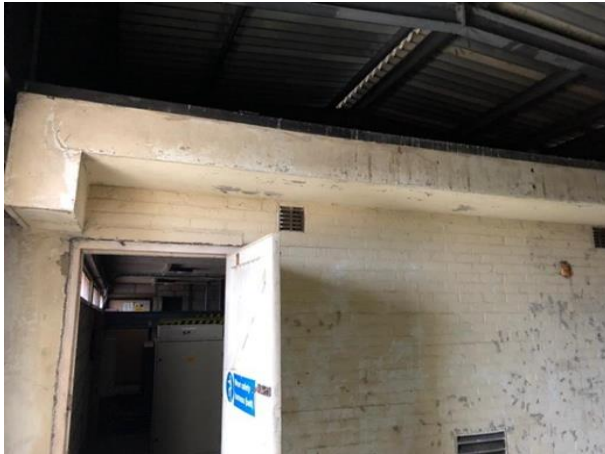
#### **Main Roof Area - Description**

Image of original tank house and lift motor room.

Area provides access on to the profiled metal roofs.

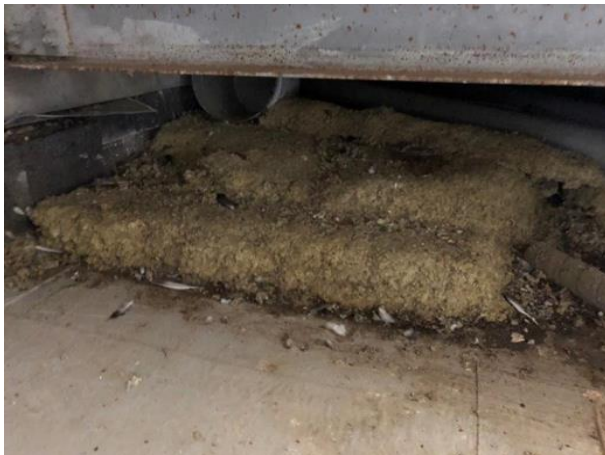
#### **Main Roof Area - Description**

Loose laid insulation identified below the profiled metal upstands and on top of the original waterproofing.

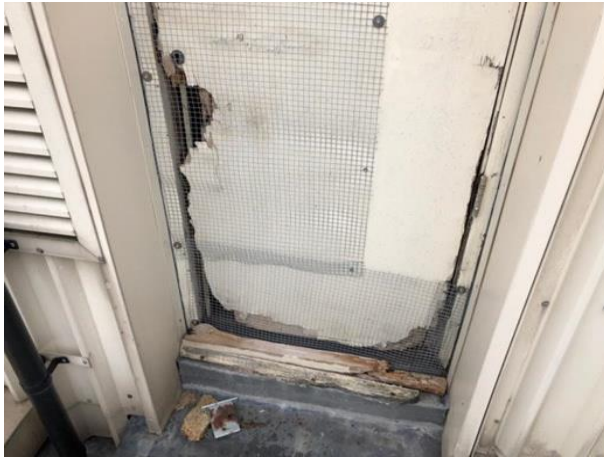
#### **Main Roof Area - Description**

**Defects:** Loose laid insulation evident, located in enclosed area below profiled metal. Numerous liquid repairs have been carried out. Door providing access to the opposing lower roof level has been wired shut due to ongoing deterioration. We recommend considerations are made to replace the doors.

Excessive damage to the access door has rendered it unsafe to use and the outside area inaccessible to one side.
