Report Document

Project: 43163

Project Name: Regina Road 58-108a
Project Address: Regina Road
London
SE25 4TT

Roof Survey Report & Recommendations

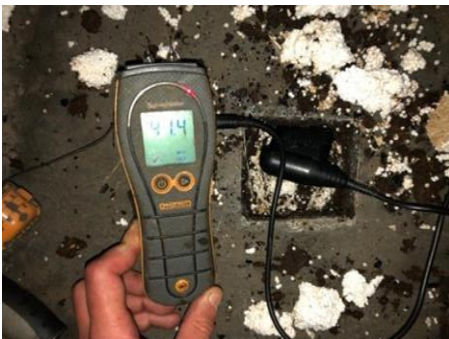
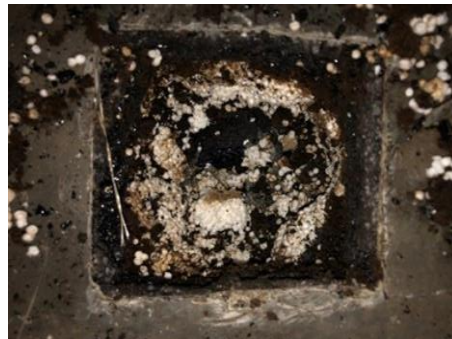
Core Sample 01 Low - Core Sample analysis revealed a moisture reading of 41.4%. Protimeter used to measure / confirm presence of moisture within existing insulation board.

- **Deck - Unscreeed Concrete**
- **Air and Vapour Control Layer - Bituminous**
- **Insulation - Expanded Polystyrene**
Thickness: 50 mm
State: Wet
- **Insulation - Fibreboard**
Thickness: 20 mm
State: Wet
- **Waterproofing - Built Up Felt**

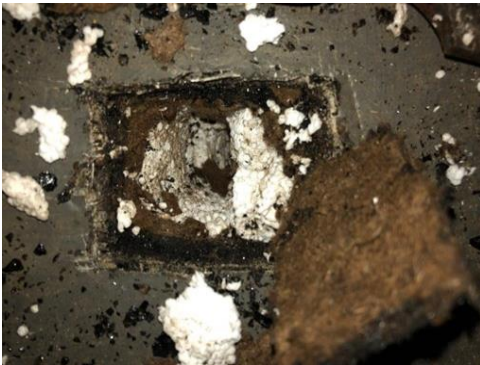
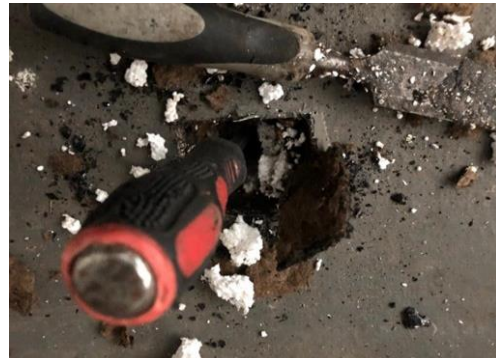
Core Sample 02 High

- Deck - Uncreeded Concrete
- Air and Vapour Control Layer - Bituminous
- Insulation - Expanded Polystyrene
Thickness: 190 mm
- Insulation - Fibreboard
Thickness: 20 mm
- Waterproofing - Built Up Felt

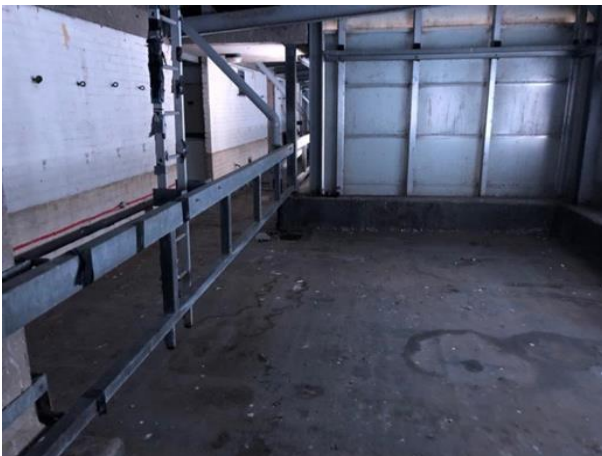
Main Roof Area - Description

Image of main field area.

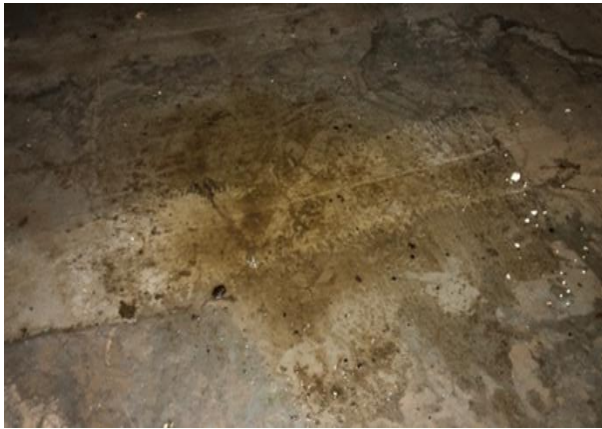
Main Roof Area - Defects and Design Notes

Areas of ponding water identified despite the profiled metal sheeting above.

Liquid repairs have also been carried out in this location.

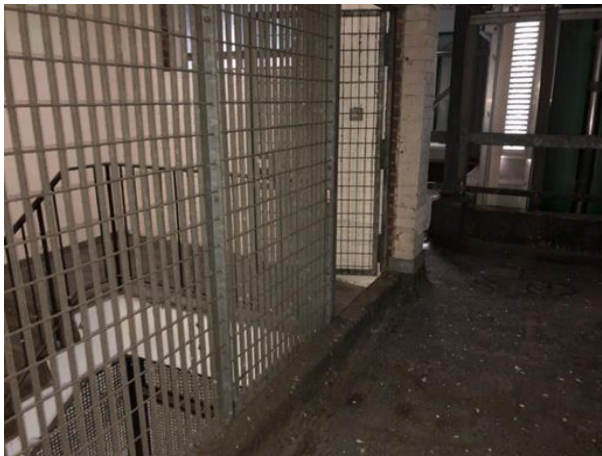
Main Roof Area - Description

Entrance gate and railings provide access the original roof area.

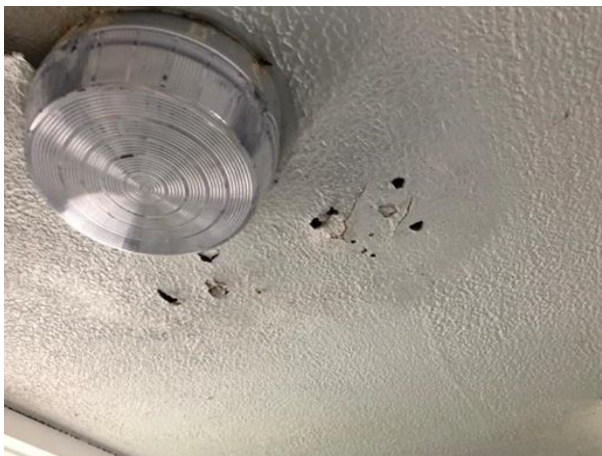
Main Roof Area - Defects and Design Notes

Bulging and staining can be seen on the ceiling of the communal walkway directly below the original roof system.

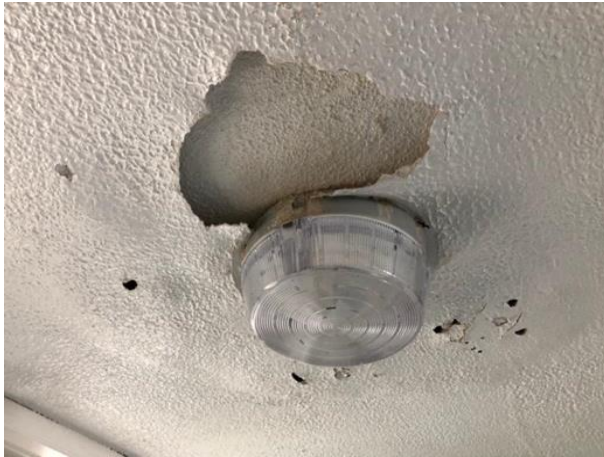
Main Roof Area - Defects and Design Notes

Damage the ceiling suggests a history of ingress from the failing waterproofing above. Water in close proximity to light fitting is a potential health & safety hazard

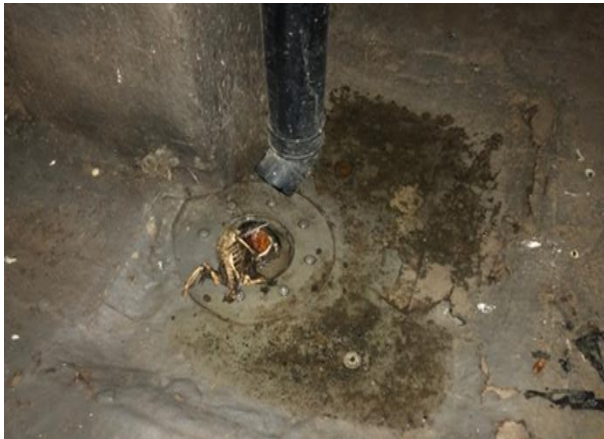
Drainage Falls - Description

Downpipes from the higher roof level discharge into internal outlets.

No leaf guards present. Debris and animal carcass can be seen blocking the outlet.

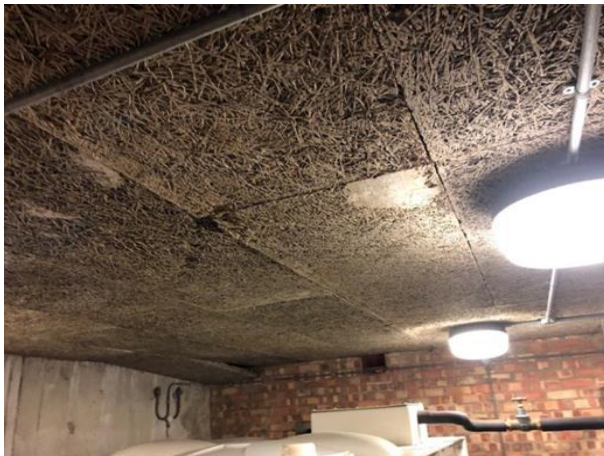
Lift Tank Notes - Description

Underside of woodwool deck to tank and lift motor room. If woodwool becomes wet it can disintegrate

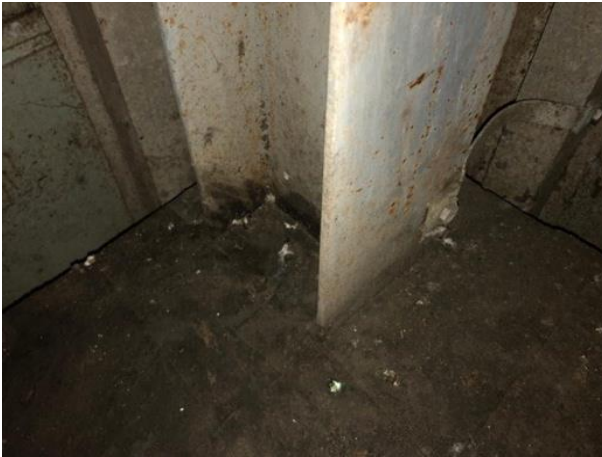
Skirtings - Description

Support steel beams are fixed into the original parapet wall structure.

Upstand to steel beam has not been terminated sufficiently to create a robust detail.

Liquid skirting installed should be 150mm above the finished roof level.

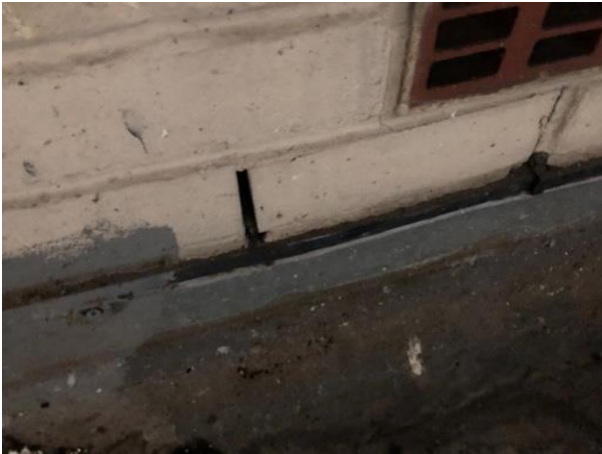
Skirtings - Description

Skirting to brickwork upstand of tank and lift motor rooms.

Minimal cover flashings present leaving the system exposed. Areas of the upstand have received liquid repairs.

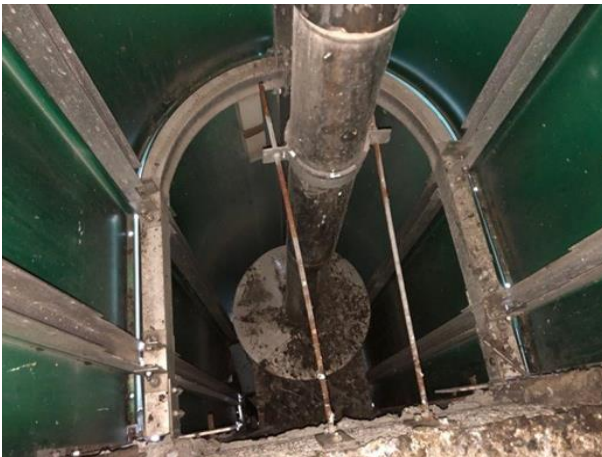
Penetrations - Description

Flue, from higher roof level, is fixed to, and runs down, the outside of the existing building, encapsulated by the cladding system.

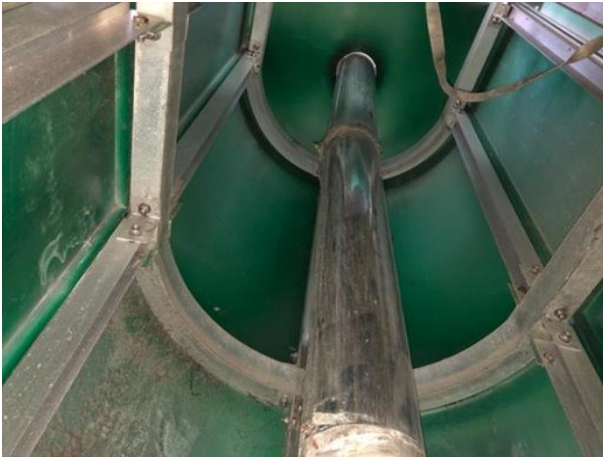
Penetrations - Description

Image showing the flue penetrate the higher roof level.

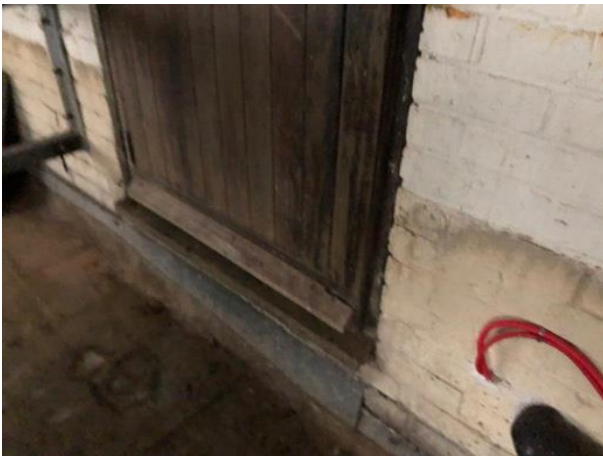
Cills - Description

Timber door threshold providing access to tank and lift motor rooms.

- Door thresholds will require raising to accommodate the proposed insulation. The thresholds are required to be 150mm above the finished roof surface to comply with BS 6229:2019.
- Subject to confirmation of the size and nature of the internal downpipes, the rainwater outlets can be refurbished with a Parafurb unit. This will provide a robust seal at the junction and in the event of blockages or 'backing-up' prevent breaching of the new system.
- Metal Cappings/Cladding are required to be temporary removed and reinstated after the waterproofing system has been installed.
- Tapered insulation is to be installed to increase the falls on the roof to direct the rainwater more efficiently to the outlets.
- Further investigations to be carried out to the profiled metal extension roof to determine its suitability for a liquid overlay subject to CA authorization.

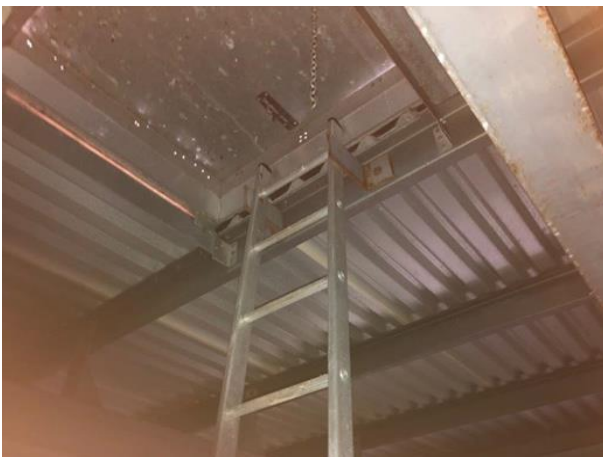
Handrails - Description

Fixed ladder and access hatch providing entry to the higher-level profiled metal roof.

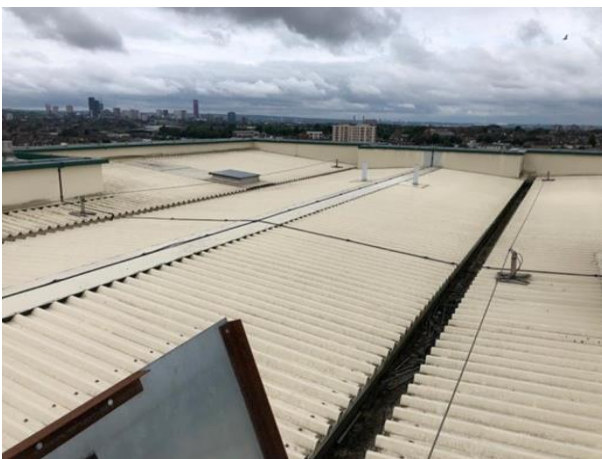
Main Roof Area - Description

Image of main field area with box valley gutters running across the roof in two locations.

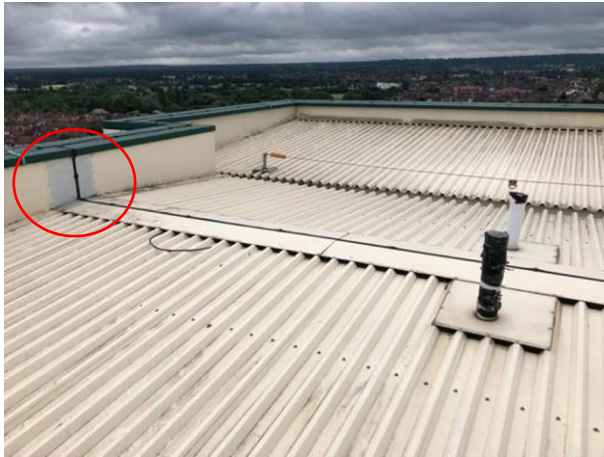
Main Roof Area - Description

Additional image of main roof area.

Note – liquid repairs undertaken to parapet wall.

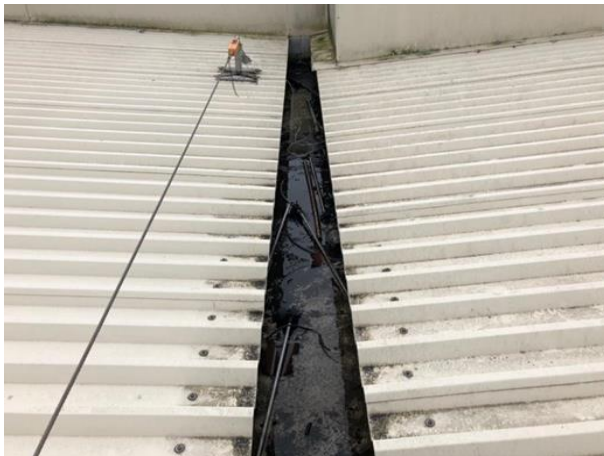
Drainage Falls - Description

Box valley gutter.

Falls within the gutter are inadequate leading to a build up of ponding water.

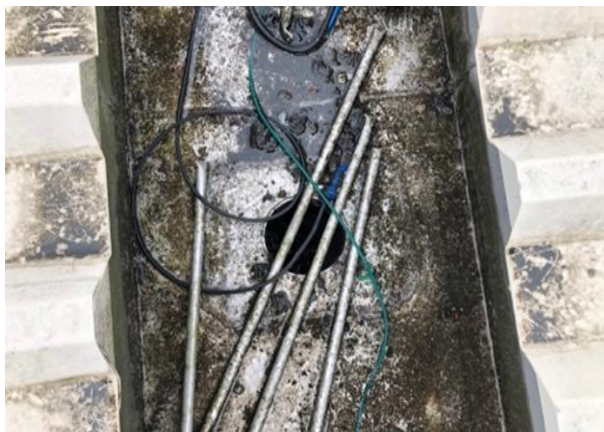
Drainage Falls - Description

Internal outlet. No leaf guard present.

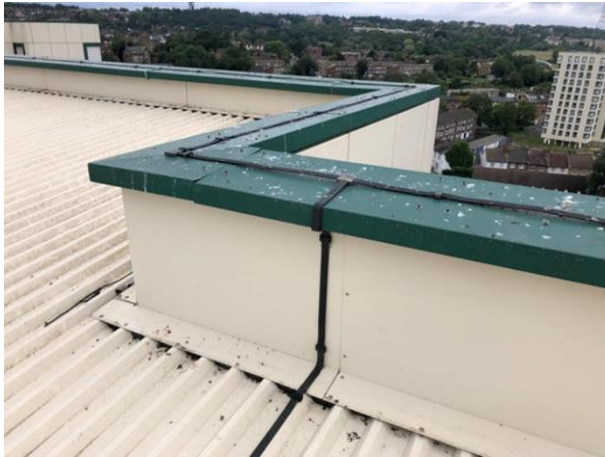
Parapets - Description

Parapets with metal cappings.

Lightning conductor cables have been fixed to the parapets and profiled metal sheeting.

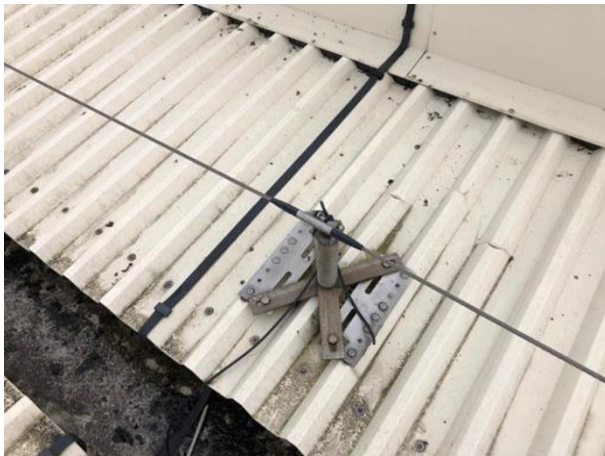
Penetrations - Description

Mansafe system has been installed to the profiled metal sheeting.

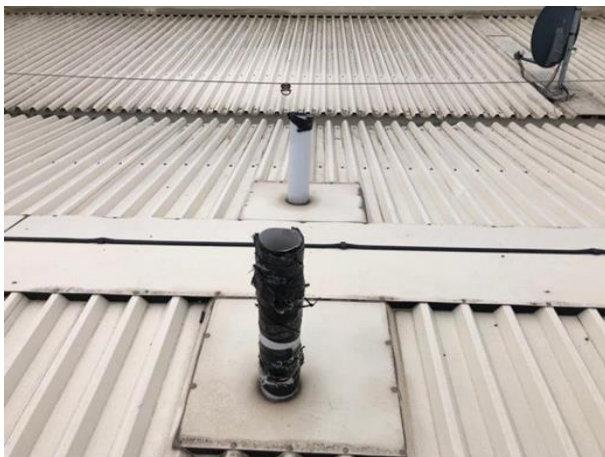
Penetrations - Description

Vent pipes penetrating the profiled metal.

Pipes have received remedial repairs.

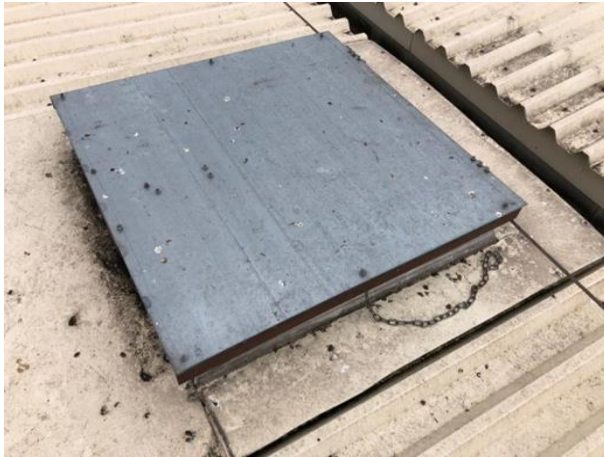
Rooflights Kerb - Description

Metal framed access hatch. Access hatch chain has broken away leaving the hatch unstable when in use.
