**58-108A REGINA ROAD
CROYDON LONDON SE25 4TT**

**STRUCTURAL ENGINEERING VISUAL
INSPECTION OF TOWER BLOCK**

24th September 2021

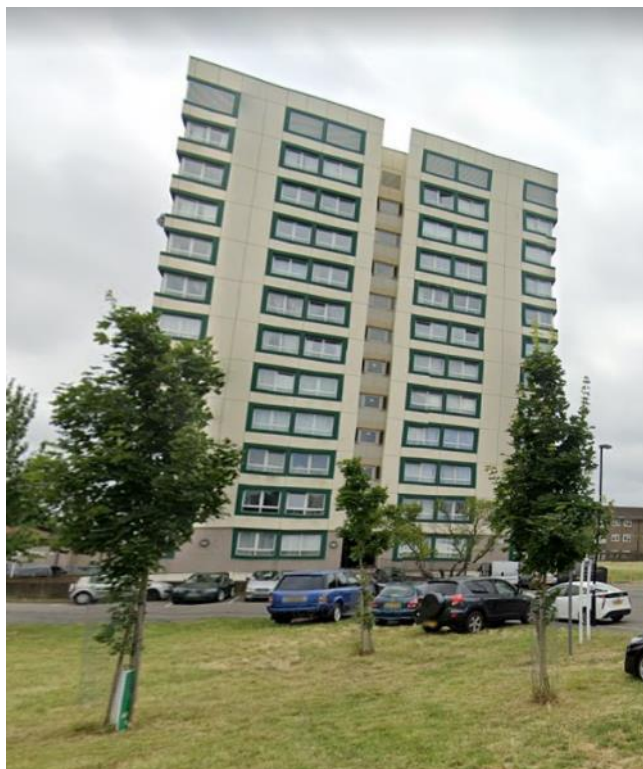
Fig 1 View of South elevation of 58-108A

The tower has subsequently been overclad, so the original cladding material could not be seen (refer Fig 1). The record drawings provided by LB Croydon (by Harley Curtain Walling) are for the over cladding works at 2-56A Regina Road and Regina Road Blocks, which are identical in layout and appearance. The drawings are dated July- September 2002 (refer example in Fig 2).

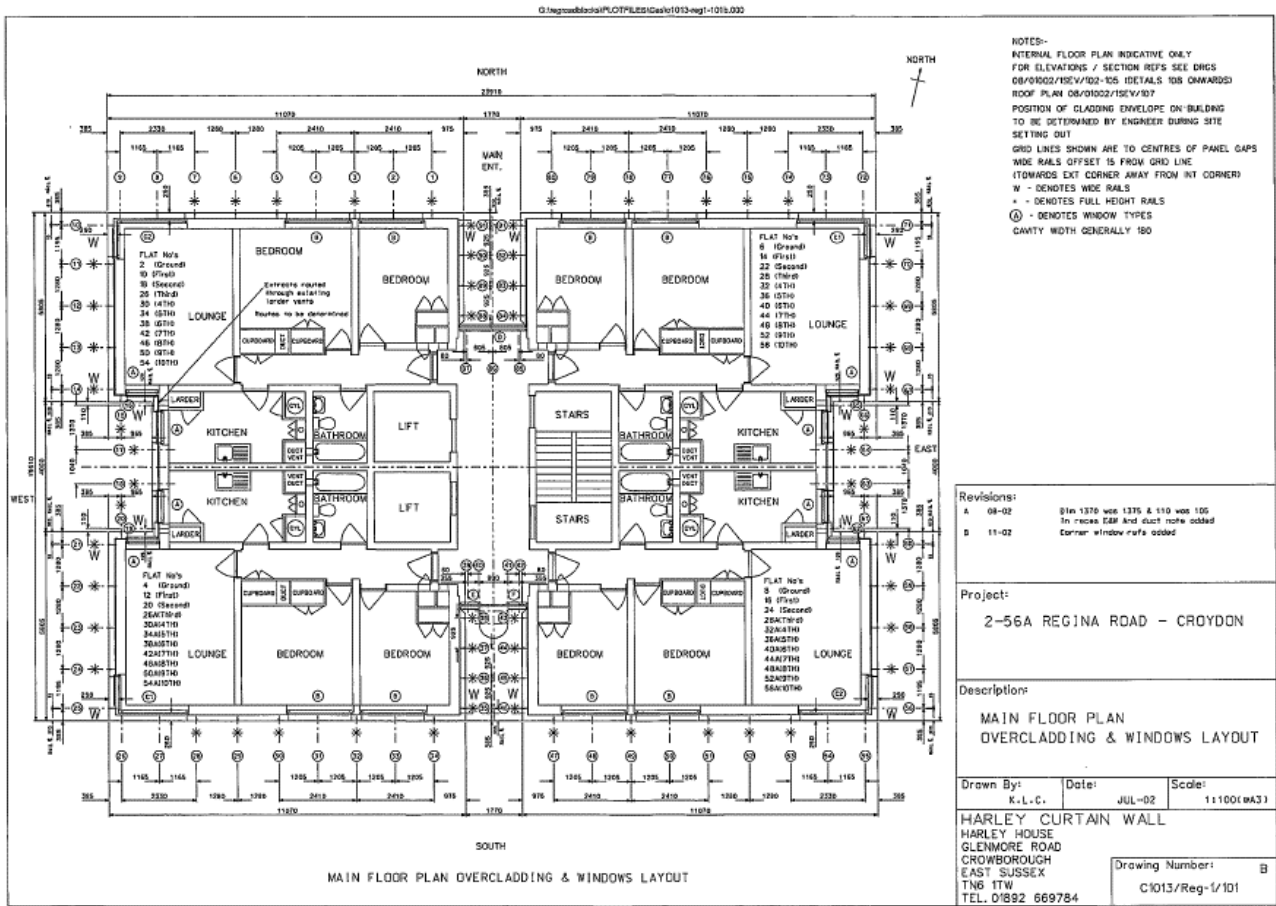
Fig 2 Overcladding record drawings Main Floor Plan 2-56A dated July 2002 showing typical flat layout

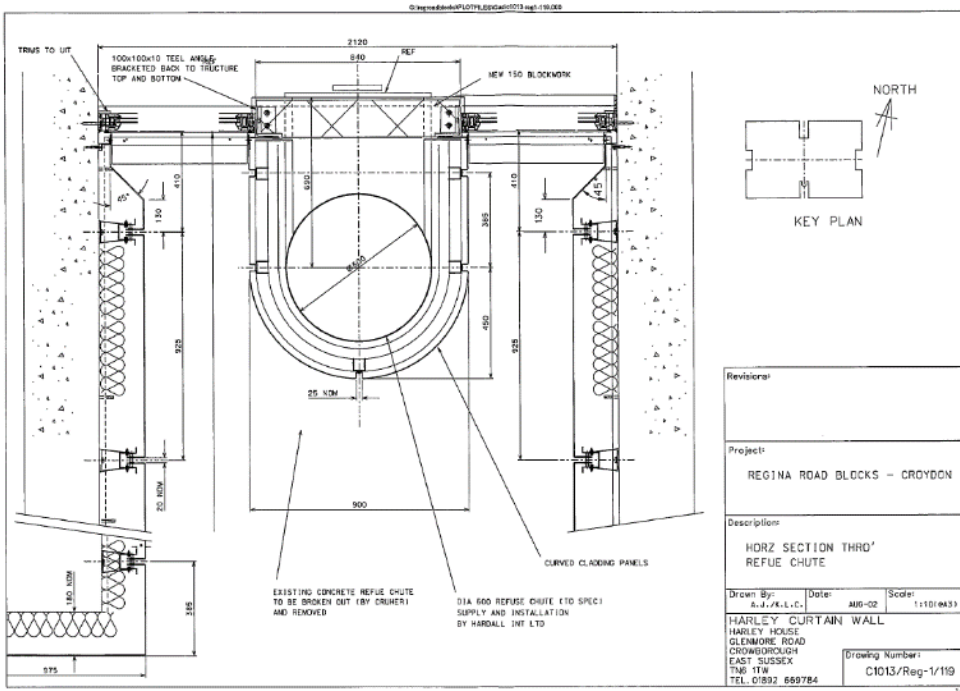
Projecting waste chutes are visible to the rear of the tower, located in a recess adjacent the central core. It appears from the record drawings that the original chutes were broken out and new added during the over cladding works (refer Fig 3).

Fig 3 Over cladding record drawings for 'Regina Road Blocks' dated Aug. 2002 showing proposed refuse chute

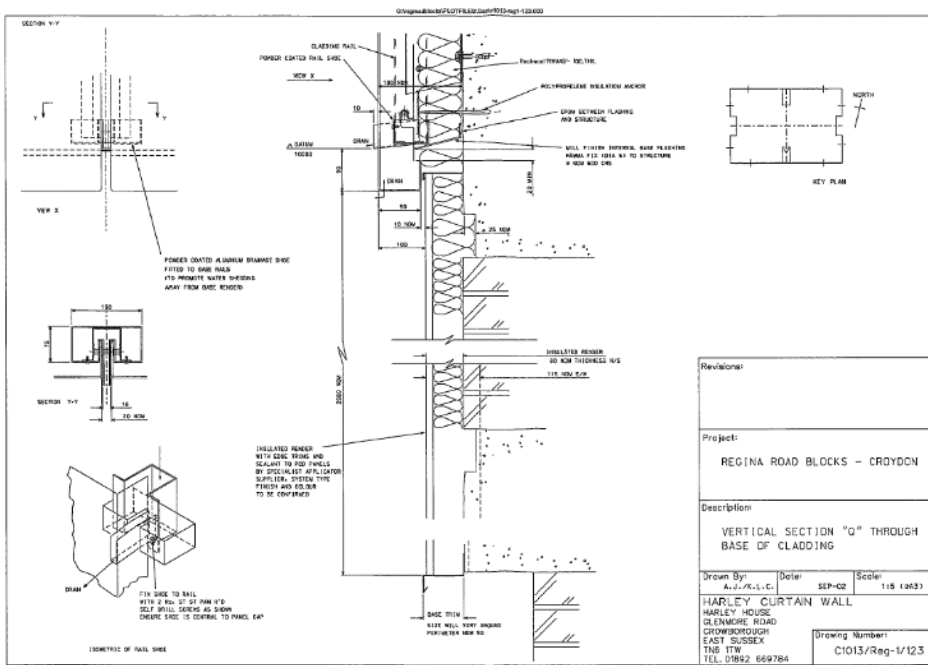
The record drawings show the cladding system comprised brackets fixed to the concrete structure supporting a system of vertical rails to which aluminium cladding panels have been fixed. This had been applied from first floor level up to roof (refer Fig 4).

Fig 4 Over cladding record drawings for 'Regina Road Blocks' dated Sept. 2002 showing detail at ground floor

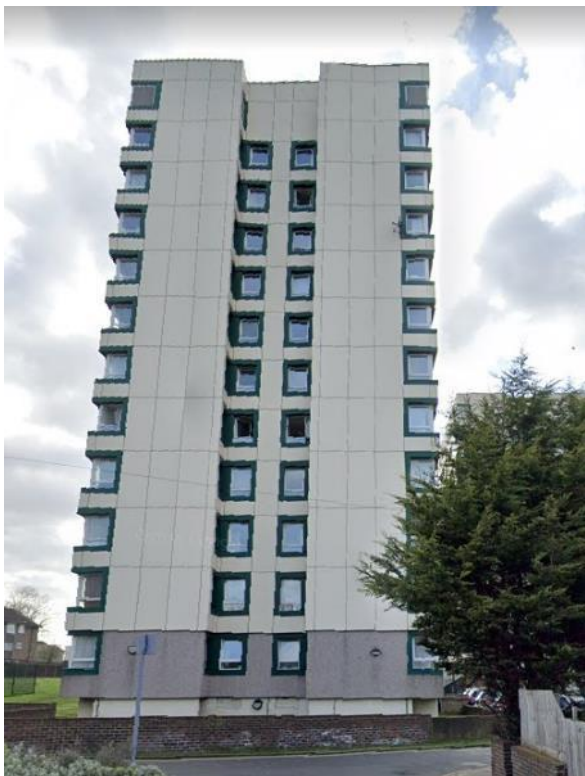
Fig 5 Western elevation 58-108A showing render finish to ground floor to over-cladding and aluminium panels used for remainder of block

Since the building has been overclad, the external primary structure is hidden from view. Nevertheless, it was possible to see the brickwork and concrete supporting the towers and enclosing the space below ground floor level, which remains exposed. This appeared to be in a generally satisfactory condition (refer Fig 5-8).

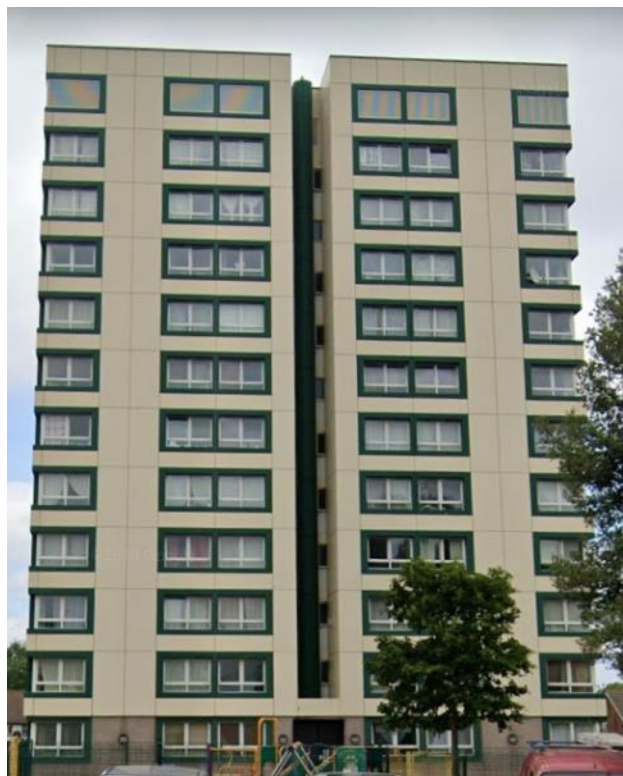
Fig 6 View of Northern elevation 58-108A showing refuse chute

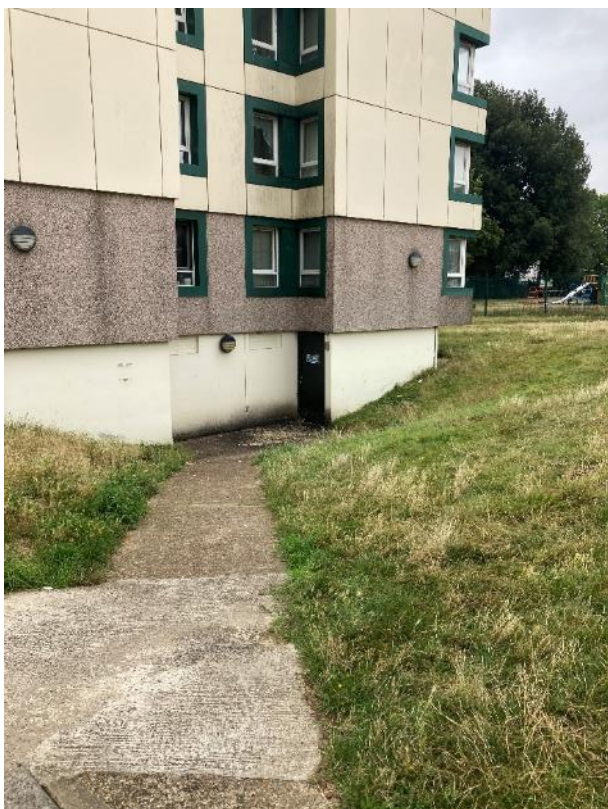
Fig 7 Eastern elevation 58-108A Showing render finish to ground floor to concrete and brick substructure

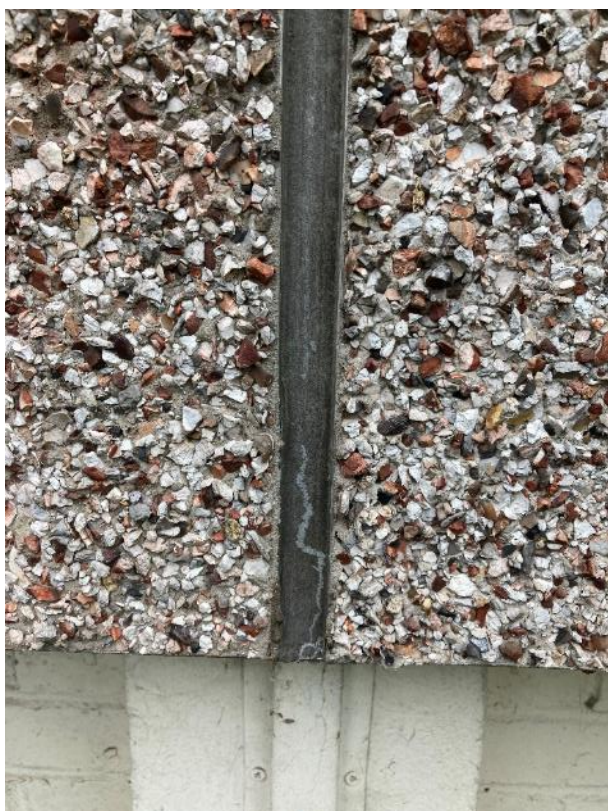
Fig 9 Close up of vertical joint between panels

An external joint in the rendered panel was also examined from ground level. This looked in good order with the infill material remaining flexible and fully filling the joint (refer Fig 9).

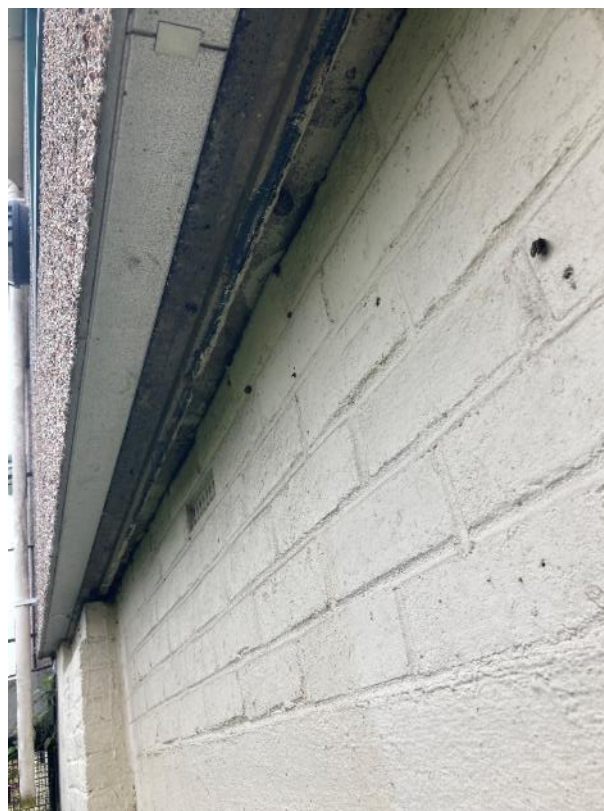
Fig 10 Underside of rendered concrete panel at ground floor level

The underside of an external panel was also inspected. This shows the render on a layer of insulation as indicated on the record drawings which is fixed onto the concrete panel (refer Fig 10). The underside of the panel looked sound with no cracks, spalling or exposed reinforcement.
