CroydonLive - Croydon Live Data

CS001484

Survey Description	2019 - M&E/Fabric	Survey Date	27/02/2019	Survey Status	OPEN	Surveyor	Kayhan Rasit	Organisation	Baily Garner LLP
Site Address	414007 Bradmore Green Library								
	Croydon								
	CR5 1PE								
Number of Buildings	1								
Number of Rooms	10								
Score									
General Summary	<p>Generally the building is in satisfactory condition, as a summary we note the main defects below: - The flat roof canopy is sagging at the main entrance, we were unable to inspect the top side of the elevation due to no access. We advise a structural engineer is appointed to review the condition of the roof/canopy. - There is evidence of damp patches to walls and ceiling within the building. The building occupiers confirmed rectification works were undertaken for the roof. However, internal remedial works have not been carried out to resolve the internal defects. - It is evident the cast iron downpipes are not in good condition, we recommend replacing all downpipes, fixtures and hopper heads. Refer to itemised breakdown in identified works. -The largest cost items within the report is further investigations for the water ingress with an a

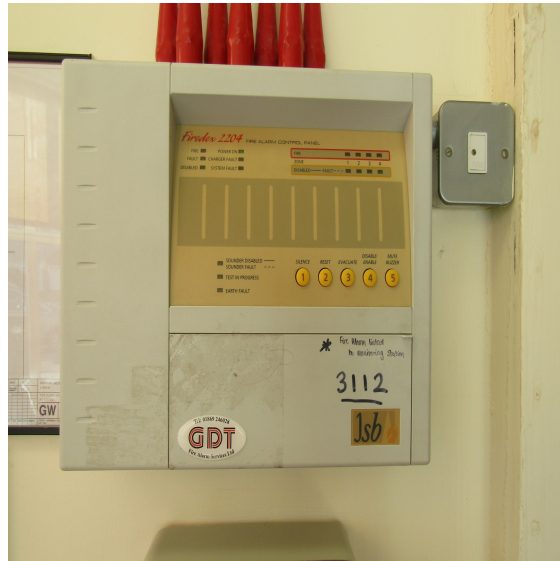
Code:	IW00312274	Site:	414007 Bradmore Green Library
Element:	FM-01 Electrical Services	Building:	
Subelement:	FM/01/5 Fire Alarm	Room:	
Item:	FM/01/13 Hard Wired	Cost:	£3500.00
Condition:	C Poor Condition	Remedy:	upgrade or renew the existing system
Priority:	2 Essential Works - next 1 - 2 years	Defect:	The fire alarm panel has aged and is approximately 15 years old

Comments: Please contact specialist to provide scope of work for remedial works We have included a provisional sum to renew the system

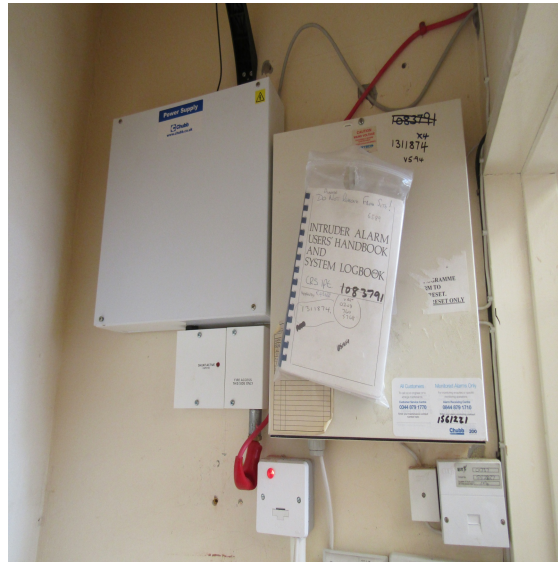
Code:	IW00312273	Site:	414007 Bradmore Green Library
Element:	FM-01 Electrical Services	Building:	414007/1
Subelement:	FM/02/6 Inturder Alarm	Room:	
Item:	FM/01/16 Hard Wired	Cost:	£3500.00
Condition:	C Poor Condition	Remedy:	Upgrade or renew the existing system. Target year: 2020-21
Priority:	2 Essential Works - next 1 - 2 years	Defect:	The intruder alarm is of age and is due for upgrade/renewal
Comments:	Refer to summary page for further detail We have included a provisional cost and advise a specialist is consulted.		
Photo:

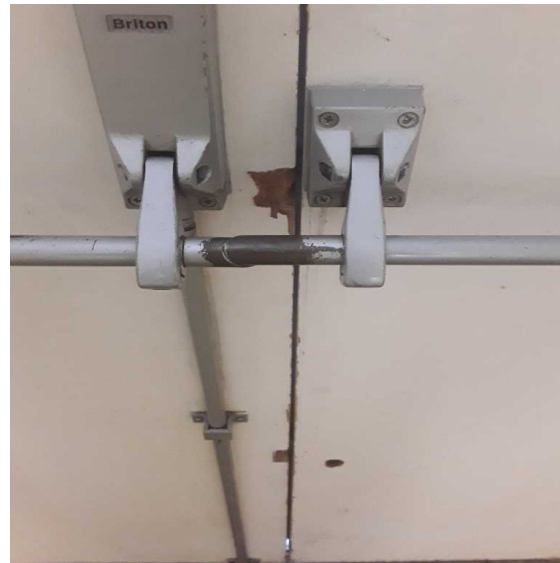
Code: IW00311631
Element: FM-03 External Structures and Elements
Subelement: FM/03/1 External Doors
Item: FM/03/01 Wood
Condition: B Satisfactory Condition

Priority: 4 Desirable Works - next 3 - 5 years

Site: 414007 Bradmore Green Library
Building: 414007/1
Room: 3
Cost: £100.00
Remedy: Fill, rub down and redecorate door
Target year: 2023-24
Defect: Evidence of several chippings to door
Defect Location: Rear fire exit to corridor

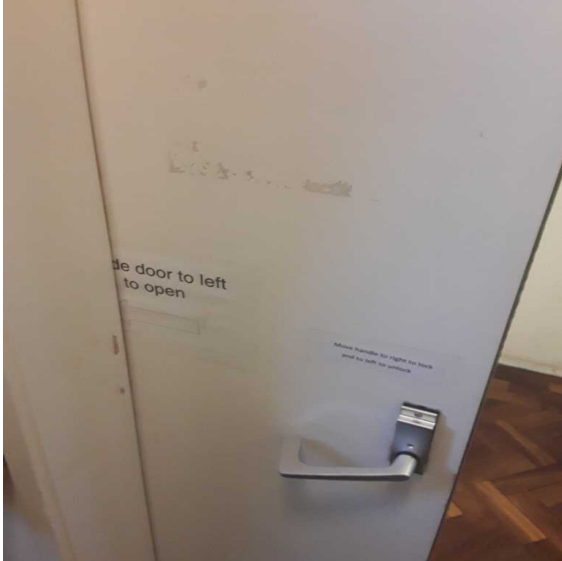
Code:	IW00311633	Site:	414007 Bradmore Green Library
Element:	FM-03 External Structures and Elements	Building:	414007/1
Subelement:	FM/03/1 External Doors	Room:	3
Item:	FM/03/01 Wood	Cost:	£70.00
Condition:	B Satisfactory Condition	Remedy:	Minor repairs to door and frame Target year: 2023-24
Priority:	4 Desirable Works - next 3 - 5 years	Defect:	Damage to door
Comments:			
Photo:

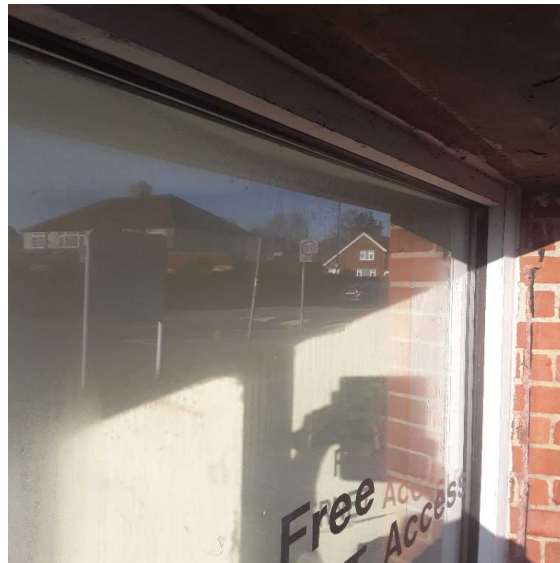
Code:	IW00311622	Site:	414007 Bradmore Green Library
Element:	FM-03 External Structures and Elements	Building:	414007/1
Subelement:	FM/03/1 External Doors	Room:	1
Item:	FM/03/02 UPVC	Cost:	£1000.00
Condition:	C Poor Condition	Remedy:	Replace with double glazed window for door x 2 Target year: 2021-22
Priority:	1 Urgent - within 6 months	Defect:	Double glazing window blown, evidence of condensation between glazing.

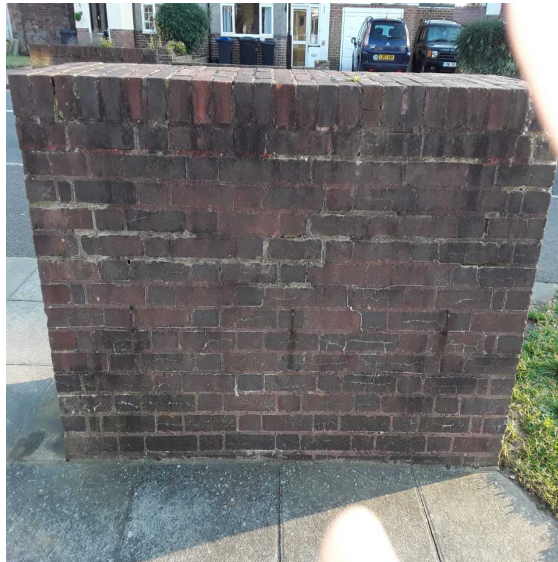
Code:	IW00311664	Site:	414007 Bradmore Green Library
Element:	FM-03 External Structures and Elements	Building:	414007/1
Subelement:	FM/03/11 Boundary Walls & Fences	Room:	
Item:	FM/03/44 Brickwork	Cost:	£1000.00
Condition:	C Poor Condition	Remedy:	Refacing brick and re pointing- Aesthetic purposes only but advise a structural engineer is contacted to confirm the condition of the wall Target year: 2021-22
Priority:	3 Essential Works - next 2 - 3 years	Defect:	Spalling of bricks and mortar joints
Comments:		Defect Location:	Front entrance self standing brick wall

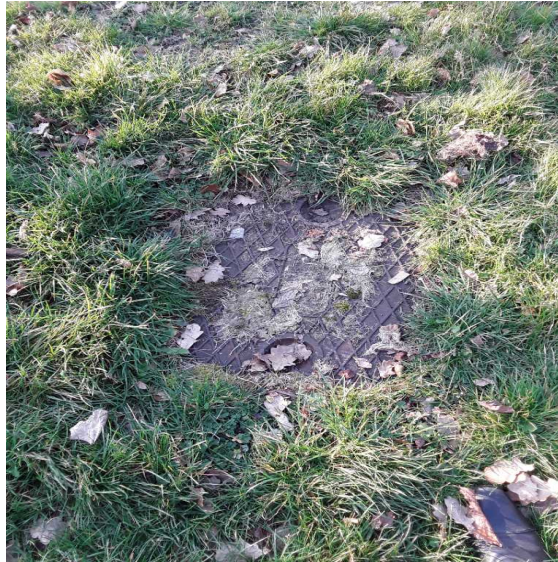
Code:	IW00311654	Site:	414007 Bradmore Green Library
Element:	FM-03 External Structures and Elements	Building:	414007/1
Subelement:	FM/03/15 Manholes/Inspection Chambers	Room:	
Item:	FM/03/67 Metal	Cost:	£250.00
Condition:	B Satisfactory Condition	Remedy:	Further investigations of manholes to be undertaken to identify the condition. Target year: 2021-22
Priority:	3 Essential Works - next 2 - 3 years	Defect:	Excess grass located around manhole covers. 1no. Manhole was inspected and note corroded internally
Comments:	Site investigation- £250		
Photo:

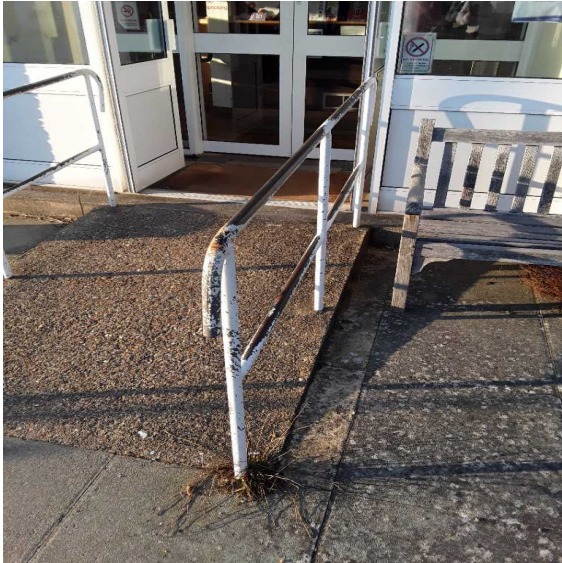
Code:	IW00311660	Site:	414007 Bradmore Green Library
Element:	FM-03 External Structures and Elements	Building:	414007/1
Subelement:	FM/03/18 Bollards / Posts	Room:	
Item:	FM/03/76 Metal	Cost:	£150.00
Condition:	C Poor Condition	Remedy:	Coat railing to clients colour choice Target year: 2022-23
Priority:	3 Essential Works - next 2 - 3 years	Defect:	Delaminated handrail
Comments:		Defect Location:	Main Entrance
Photo:

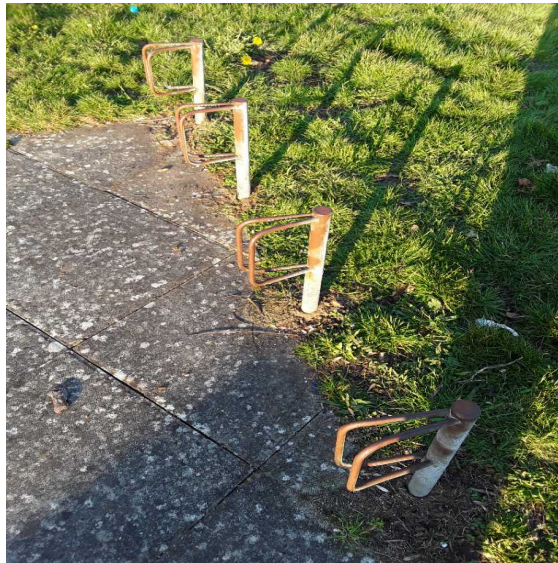
Code:	IW00311661	Site:	414007 Bradmore Green Library
Element:	FM-03 External Structures and Elements	Building:	414007/1
Subelement:	FM/03/18 Bollards / Posts	Room:	
Item:	FM/03/76 Metal	Cost:	£250.00
Condition:	C Poor Condition	Remedy:	Apply a rust and corrosion inhibitor, once dried apply paint (colour choice preference from the client) Target year: 2022-23
Priority:	3 Essential Works - next 2 - 3 years	Defect:	Rusty bike posts
Comments:	Labour and rectification works - Estimated day rate of £250 (paint and inhibitor included)		
Photo:

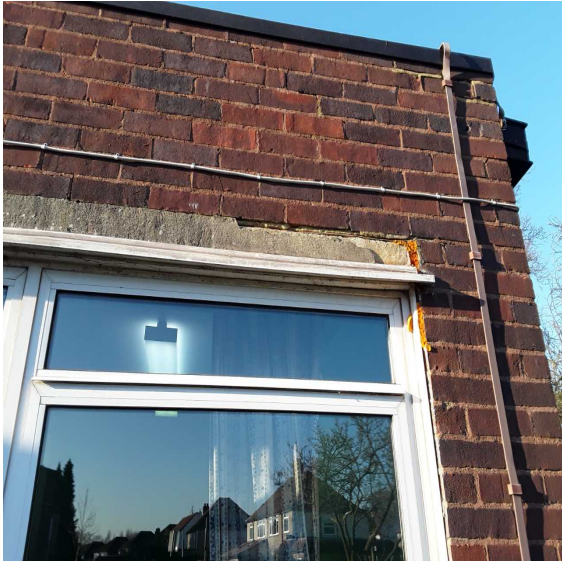
Code:	IW00311657	Site:	414007 Bradmore Green Library
Element:	FM-03 External Structures and Elements	Building:	414007/1
Subelement:	FM/03/3 External Walls Structure	Room:	
Item:	FM/03/10 Cavity brickwork/ blockwork	Cost:	£200.00
Condition:	C Poor Condition	Remedy:	Chop out damaged/spalling concrete; recast basic finish Target year: 2021-22
Priority:	3 Essential Works - next 2 - 3 years	Defect:	Evidence of cracked concrete lintels above windows
Comments:			
Photo:

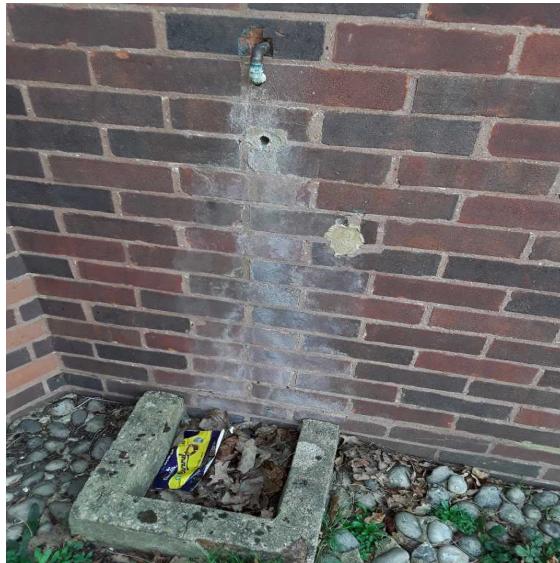
Code:	IW00311663	Site:	414007 Bradmore Green Library
Element:	FM-03 External Structures and Elements	Building:	414007/1
Subelement:	FM/03/3 External Walls Structure	Room:	
Item:	FM/03/10 Cavity brickwork/ blockwork	Cost:	£250.00
Condition:	B Satisfactory Condition	Remedy:	Rake off and clean residue/staining off brickwork Target year: 2022-23
Priority:	3 Essential Works - next 2 - 3 years	Defect:	Several locations of staining to brickwork,mainly located around downpipes

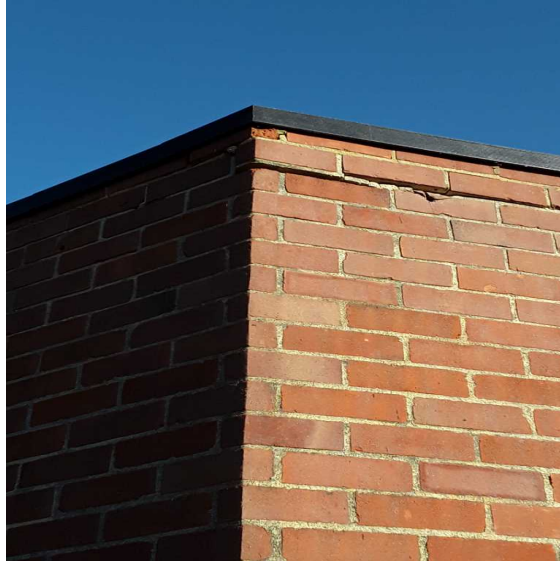
Code:	IW00311648	Site:	414007 Bradmore Green Library
Element:	FM-03 External Structures and Elements	Building:	414007/1
Subelement:	FM/03/3 External Walls Structure	Room:	
Item:	FM/03/10 Cavity brickwork/ blockwork	Cost:	£60.00
Condition:	B Satisfactory Condition	Remedy:	Rake out and repoint joints to match existing Target year: 2023-24
Priority:	4 Desirable Works - next 3 - 5 years	Defect:	Unsatisfactory mortar joints below perimeter roof trim

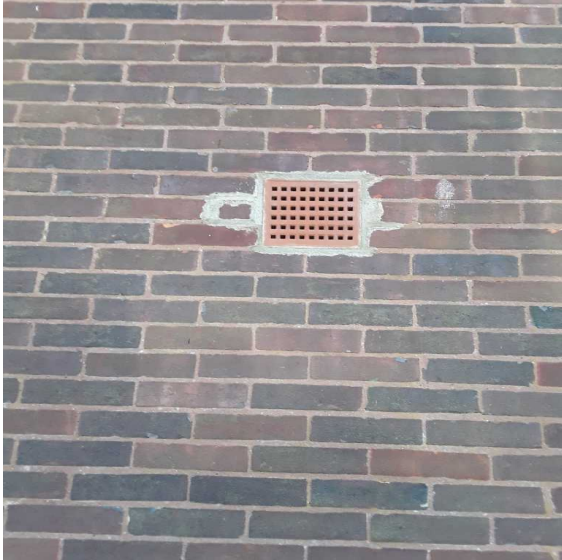
Code:	IW00311650	Site:	414007 Bradmore Green Library
Element:	FM-03 External Structures and Elements	Building:	414007/1
Subelement:	FM/03/3 External Walls Structure	Room:	
Item:	FM/03/10 Cavity brickwork/ blockwork	Cost:	£60.00
Condition:	B Satisfactory Condition	Remedy:	Repoint to match existing Target year: 2023-24
Priority:	4 Desirable Works - next 3 - 5 years	Defect:	Poor repointing around external air vents
Comments:			
Photo:

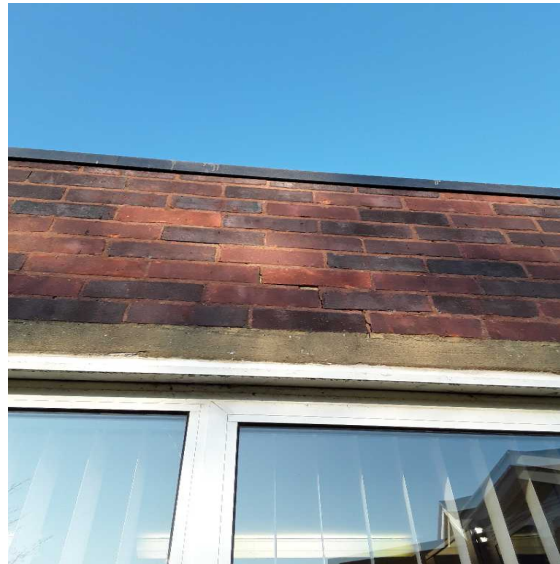
Code:	IW00311655	Site:	414007 Bradmore Green Library
Element:	FM-03 External Structures and Elements	Building:	414007/1
Subelement:	FM/03/3 External Walls Structure	Room:	
Item:	FM/03/10 Cavity brickwork/ blockwork	Cost:	£60.00
Condition:	B Satisfactory Condition	Remedy:	Rake out and repointing to match existing Target year: 2023-24
Priority:	4 Desirable Works - next 3 - 5 years	Defect:	Horizontal cracking mortar joints

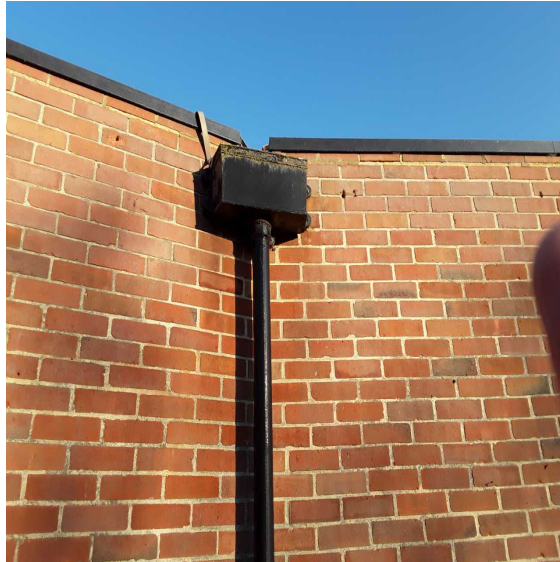
Code:	IW00311658	Site:	414007 Bradmore Green Library
Element:	FM-03 External Structures and Elements	Building:	414007/1
Subelement:	FM/03/3 External Walls Structure	Room:	
Item:	FM/03/10 Cavity brickwork/ blockwork	Cost:	£250.00
Condition:	B Satisfactory Condition	Remedy:	We recommend cutting out the existing, replace and re point bricks to match existing Target year: 2023-24
Priority:	4 Desirable Works - next 3 - 5 years	Defect:	Holes have been drilled into the brickwork upper level surrounding the building
Comments:	Undertake for aesthetic purposes if required		
Photo:

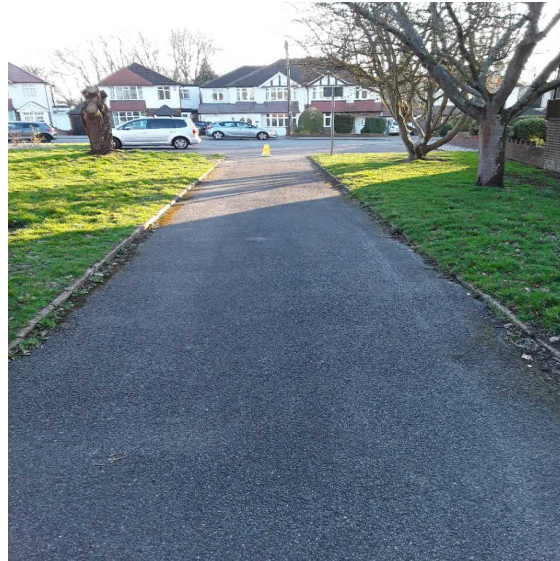
Code:	IW00311662	Site:	414007 Bradmore Green Library
Element:	FM-03 External Structures and Elements	Building:	414007/1
Subelement:	FM/03/7 Roads/Hard Standing Areas for Traffic	Room:	
Item:	FM/03/27 Gravel Surface	Cost:	£0.00
Condition:	B Satisfactory Condition	Remedy:	
Priority:	0 No priority	Defect:	No defects evident at time of inspection
Comments:			
Photo:

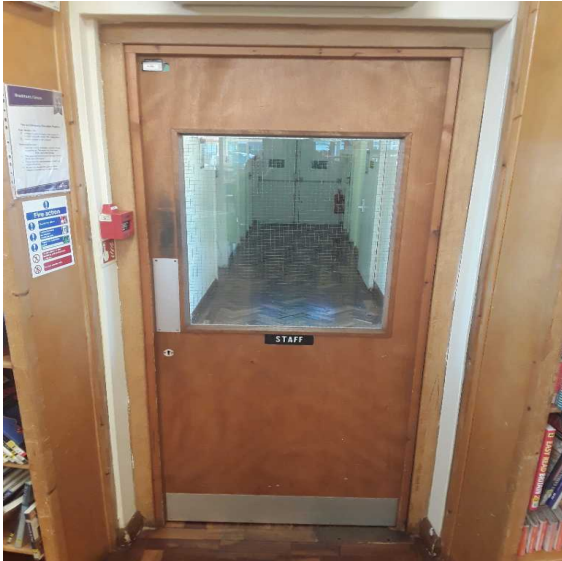
Code:	IW00311627	Site:	414007 Bradmore Green Library
Element:	FM-05 Internal Walls, Doors & Ceilings	Building:	414007/1
Subelement:	FM/05/1 Doors (Specify Location)	Room:	2
Item:	FM/05/01 Timber with glazed panels	Cost:	£300.00
Condition:	C Poor Condition	Remedy:	Ease and adjust door. if jam is not rectified, replace to match existing Target year: 2020-21
Priority:	2 Essential Works - next 1 - 2 years	Defect:	The door does not positively close due to a jam
Comments:	IMAGE NOT PRESENT- Provisional cost of £300 included for rectification works		
Photo:

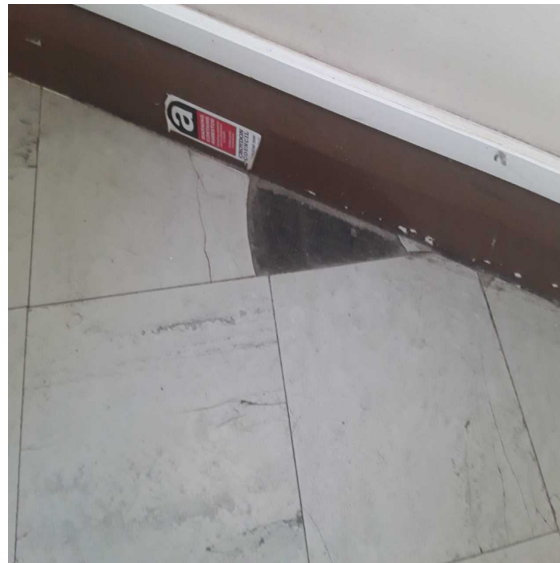
Code:	IW00311636	Site:	414007 Bradmore Green Library
Element:	FM-05 Internal Walls, Doors & Ceilings	Building:	414007/1
Subelement:	FM/05/3 Floor finishes (Specify Location)	Room:	4
Item:	FM/05/19 Vinyl tiles	Cost:	£150.00
Condition:	C Poor Condition	Remedy:	Replace tile carefully to ensure dust or fibres are not airborne Target year: 2021-22
Priority:	2 Essential Works - next 1 - 2 years	Defect:	Broken ceramic tiles - asbestos containing material

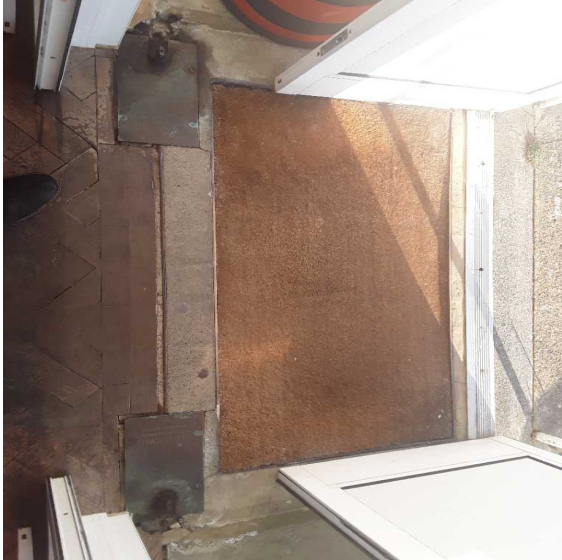
Code:	IW00311621	Site:	414007 Bradmore Green Library
Element:	FM-05 Internal Walls, Doors & Ceilings	Building:	414007/1
Subelement:	FM/05/3 Floor finishes (Specify Location)	Room:	1
Item:	FM/05/22 Other - specify	Cost:	£50.00
Condition:	B Satisfactory Condition	Remedy:	Replace matt if desirable No major damage to concrete but note to monitor if damage becomes worst Target year: 2022-23
Priority:	4 Desirable Works - next 3 - 5 years	Defect:	Wear and tear to front entrance matt Minor damage to concrete floor during removal of original doors
Comments:	Matt replacement £50	Defect Location:	Main entrance
Photo:

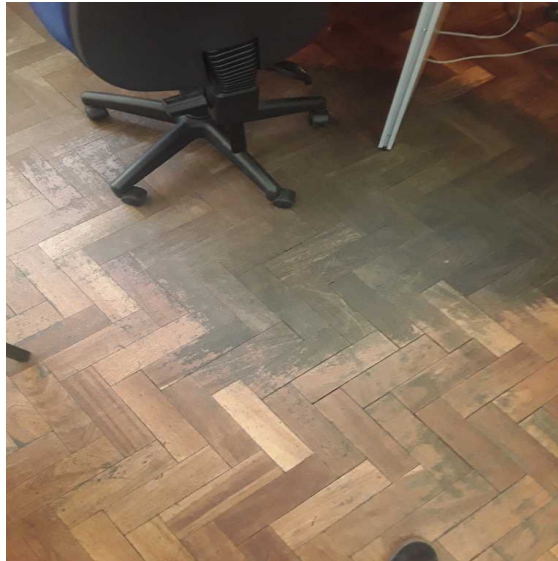
Code:	IW00311625	Site:	414007 Bradmore Green Library
Element:	FM-05 Internal Walls, Doors & Ceilings	Building:	414007/1
Subelement:	FM/05/3 Floor finishes (Specify Location)	Room:	2
Item:	FM/05/22 Other - specify	Cost:	£1050.00
Condition:	B Satisfactory Condition	Remedy:	Sand down all flooring, infill resin to gaps and allow 2 coats of varnish Target year: 2021-22
Priority:	3 Essential Works - next 2 - 3 years	Defect:	Wear and tear to parquet flooring
Comments:	Cost for floor area has been reduced to exclude book shelves and fixed furniture		
Photo:

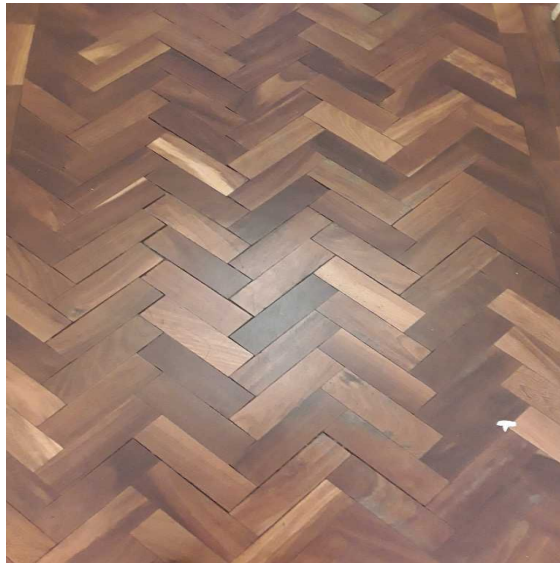
Code:	IW00311629	Site:	414007 Bradmore Green Library
Element:	FM-05 Internal Walls, Doors & Ceilings	Building:	414007/1
Subelement:	FM/05/3 Floor finishes (Specify Location)	Room:	3
Item:	FM/05/22 Other - specify	Cost:	£600.00
Condition:	B Satisfactory Condition	Remedy:	Sand down all flooring, infill resin to gaps and allow 2 coats of varnish Target year: 2022-23
Priority:	3 Essential Works - next 2 - 3 years	Defect:	Wear and tear to parquet flooring

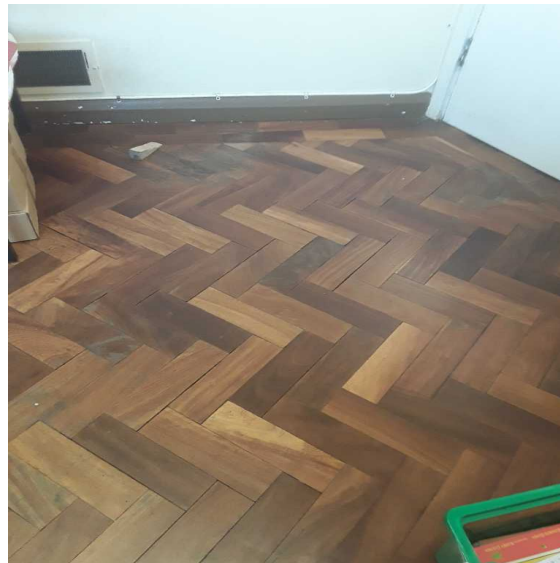
Code:	IW00311638	Site:	414007 Bradmore Green Library
Element:	FM-05 Internal Walls, Doors & Ceilings	Building:	414007/1
Subelement:	FM/05/3 Floor finishes (Specify Location)	Room:	5
Item:	FM/05/22 Other - specify	Cost:	£435.00
Condition:	B Satisfactory Condition	Remedy:	Sand down all flooring, infill resin to gaps and allow 2 coats of varnish Target year: 2021-22
Priority:	3 Essential Works - next 2 - 3 years	Defect:	Wear and tear to parquet flooring

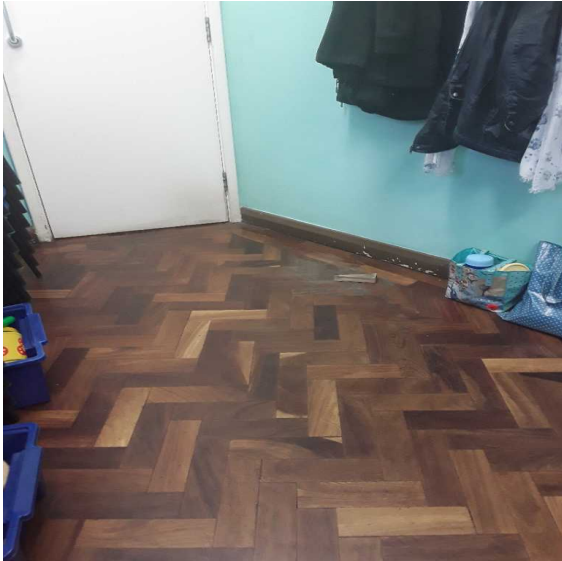
Code:	IW00311644	Site:	414007 Bradmore Green Library
Element:	FM-05 Internal Walls, Doors & Ceilings	Building:	414007/1
Subelement:	FM/05/3 Floor finishes (Specify Location)	Room:	8
Item:	FM/05/22 Other - specify	Cost:	£450.00
Condition:	B Satisfactory Condition	Remedy:	Sand down all flooring, infill resin to gaps and allow 2 coats of varnish Target year: 2022-23
Priority:	3 Essential Works - next 2 - 3 years	Defect:	Wear and tear to parquet flooring
Comments:			
Photo:

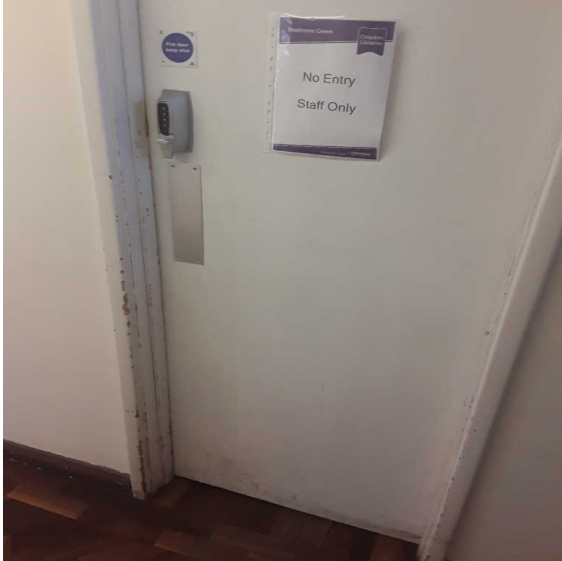
Code:	IW00311628	Site:	414007 Bradmore Green Library
Element:	FM-05 Internal Walls, Doors & Ceilings	Building:	414007/1
Subelement:	FM/05/6 Screens / partitions	Room:	2
Item:	FM/05/31 Single glazed timber	Cost:	£250.00
Condition:	B Satisfactory Condition	Remedy:	Redecoration required Target year: 2023-24
Priority:	4 Desirable Works - next 3 - 5 years	Defect:	Paint peeling away from doors
Comments:			
Photo:

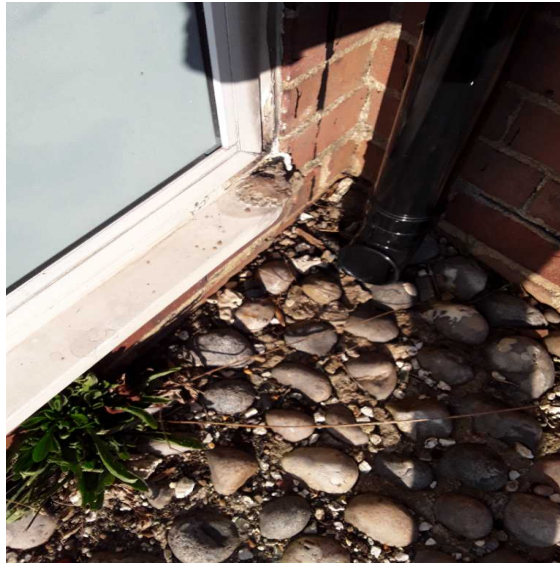
Code:	IW00311651	Site:	414007 Bradmore Green Library
Element:	FM-05 Internal Walls, Doors & Ceilings	Building:	414007/1
Subelement:	FM/05/6 Screens / partitions	Room:	
Item:	FM/05/33 UPVC double glazed	Cost:	£250.00
Condition:	B Satisfactory Condition	Remedy:	We advise the corrosion is monitored and if evidently changes we recommend this is replaced/repaired Target year: 2021-22
Priority:	3 Essential Works - next 2 - 3 years	Defect:	Minor corrosion to UPVC window ledge
Comments:	£250 provisional cost	Defect Location:	Main Entrance Elevation
Photo:

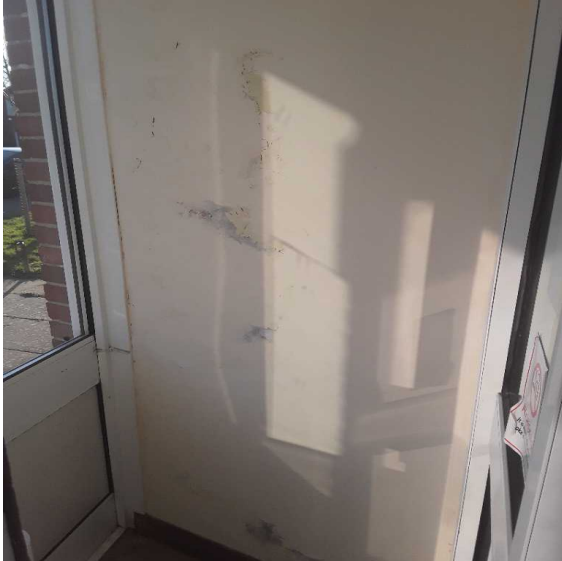
Code:	IW00311620	Site:	414007 Bradmore Green Library
Element:	FM-05 Internal Walls, Doors & Ceilings	Building:	414007/1
Subelement:	FM/05/7 Wall Finishes (Specify Location)	Room:	1
Item:	FM/05/38 Decorated only	Cost:	£100.00
Condition:	C Poor Condition	Remedy:	Replace plasterboard to wall Note: Inspect underside of plasterboard prior to replacing Target year: 2020-21
Priority:	2 Essential Works - next 1 - 2 years	Defect:	Evidence of damp to wall
Comments:		Defect Location:	Adjacent to main entrance
Photo:

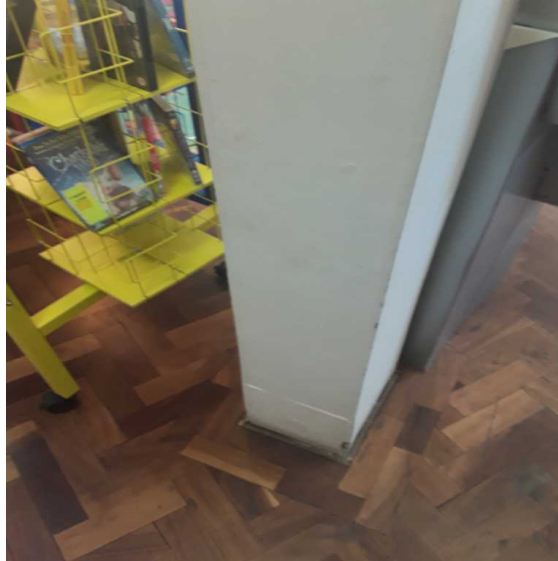
Code:	IW00311624	Site:	414007 Bradmore Green Library
Element:	FM-05 Internal Walls, Doors & Ceilings	Building:	414007/1
Subelement:	FM/05/7 Wall Finishes (Specify Location)	Room:	2

Item:	FM/05/38 Decorated only	Cost:	£3726.46
Condition:	B Satisfactory Condition	Remedy:	Redecorate all walls and column boxing with emulsion paint Target year: 2022-23
Priority:	3 Essential Works - next 2 - 3 years	Defect:	Soiled and Worn
Comments:	Defect Location: All of Library- see comment below Entrance Lobby = 10.6m2 - excluding windows and doors Lending Library = 26m2 - excluding windows and openings. Note the wall surfaces have only been accounted for above the book shelves (height 2.07 m) and columns. Corridor = 29.5 m2 - excluding windows and doors Toilet = 4.73 m2 - excluding windows and doors Activity room = 30.6 m2- excluding doors Boiler Room = 13,8 m2 - excluding windows and doors Cleaners cupboard = 9.9 m2 - excluding windows and doors Staff Room = 28.1m2 - excluding windows and doors Staff/disabled toilets = 7.15m2 - excluding windows and doors Total= 160.38 x £17 per m2 Additional contingency of £1000 for decorative repairs

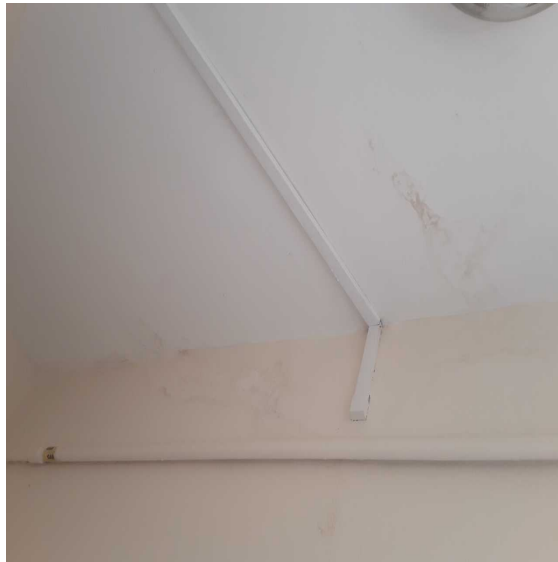
Code:	IW00311635	Site:	414007 Bradmore Green Library
Element:	FM-05 Internal Walls, Doors & Ceilings	Building:	414007/1
Subelement:	FM/05/7 Wall Finishes (Specify Location)	Room:	4
Item:	FM/05/38 Decorated only	Cost:	£500.00
Condition:	C Poor Condition	Remedy:	further intrusive testing required to identify staining for probable cause Target year: 2019-20
Priority:	1 Urgent - within 6 months	Defect:	Damp staining at high level Cracking at high level above window to external wall- PHOTO NOT EVIDENTLY CLEAR

Comments: £500 - further investigations and provisional cost for rectification works

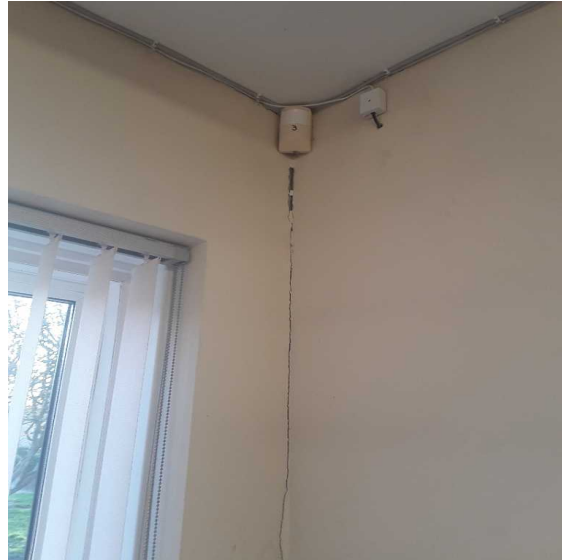
Code:	IW00311639	Site:	414007 Bradmore Green Library
Element:	FM-05 Internal Walls, Doors & Ceilings	Building:	414007/1
Subelement:	FM/05/7 Wall Finishes (Specify Location)	Room:	5
Item:	FM/05/38 Decorated only	Cost:	£200.00
Condition:	C Poor Condition	Remedy:	Make good all hairline cracks- apply a fine filler, rub down and make good- Included within general wall finish item Remove affected mould areas, apply stain block and redecorate- Note: Initial investigation to ensure the cause for the mould has been eradicated prior to making good. Target year: 2020-21
Priority:	2 Essential Works - next 1 - 2 years	Defect:	Cracking to ceiling line and corner of room Evidence of mould to wall finish
Comments:	Costs include prior investigation and rectification works		
Photo:

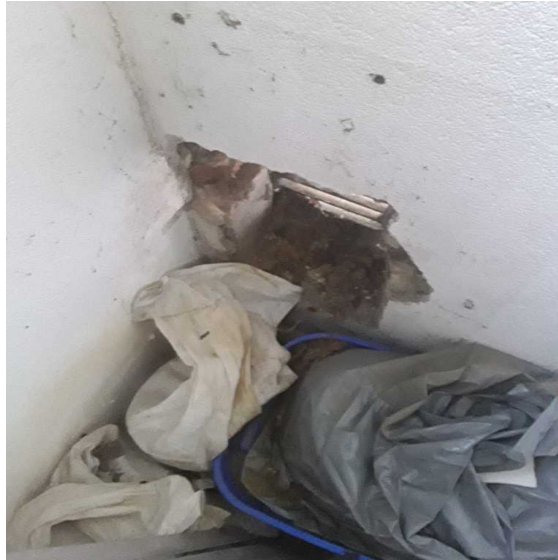
Code:	IW00311641	Site:	414007 Bradmore Green Library
Element:	FM-05 Internal Walls, Doors & Ceilings	Building:	414007/1
Subelement:	FM/05/7 Wall Finishes (Specify Location)	Room:	6
Item:	FM/05/41 Other type - specify	Cost:	£30.00
Condition:	C Poor Condition	Remedy:	Fill damaged wall around vent and match paint. Install new vent once made wall has been made good. Hairline cracks to be carried out with general decoration works. Target year: 2020-21
Priority:	2 Essential Works - next 1 - 2 years	Defect:	Incomplete opening for vent to corridor Painted render - crack below and above window
Comments:	Vent Cover £30 Making good included in general decoration rate.		
Photo:

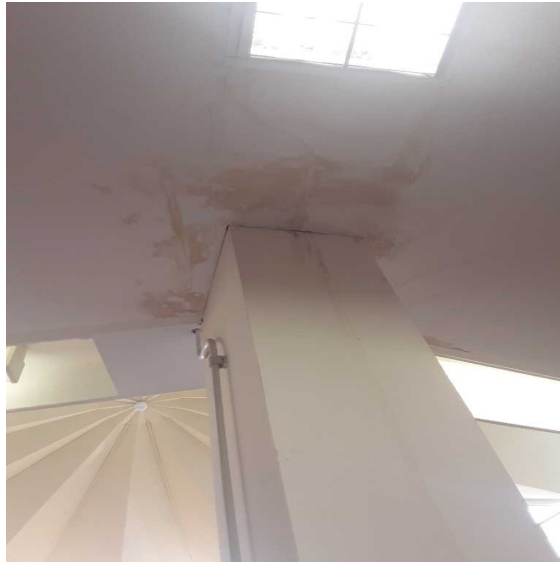
Code:	IW00311618	Site:	414007 Bradmore Green Library
Element:	FM-05 Internal Walls, Doors & Ceilings	Building:	414007/1
Subelement:	FM/05/8 Celings finishes (Specify Location)	Room:	1

Item:	FM/05/42 Plastered and decorated	Cost:	£4000.00
Condition:	C Poor Condition	Remedy:	Carry spot testing for wet rot/dry rot within the ceiling areas. Test to be undertaken to identify probable the cause for damp within the ceiling areas. Target year: 2020-21
Priority:	2 Essential Works - next 1 - 2 years	Defect:	Evidence of water ingress to ceiling plasterboard in several locations within the Library. Water staining particularly around the columns in main library area. It is likely to be a previous issue now resolved by the new roof but has not been made good internally
Comments:	Defect Location: SEE PHOTOS We have made an allowance of £2500 for further testing to be undertaken additional £1500 to stain block/decorate affected areas. Please note we have not made an allowance for wet/dry rot works to be undertaken and advise these cost may be extensive if identified.

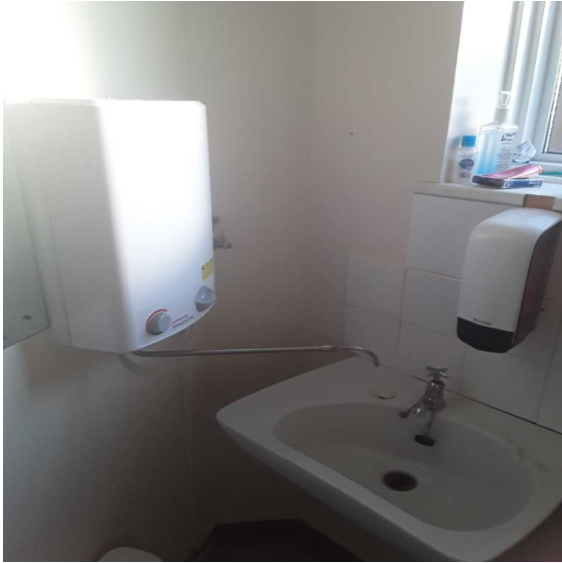
Code:	IW00311637	Site:	414007 Bradmore Green Library
Element:	FM-06 Mechanical Services	Building:	414007/1
Subelement:	FM/06/5 Water Services	Room:	4
Item:	FM/06/32 Electric Water Heater	Cost:	£0.00
Condition:	B Satisfactory Condition	Remedy:	
Priority:	0 No priority	Defect:	
Comments:			
Photo:

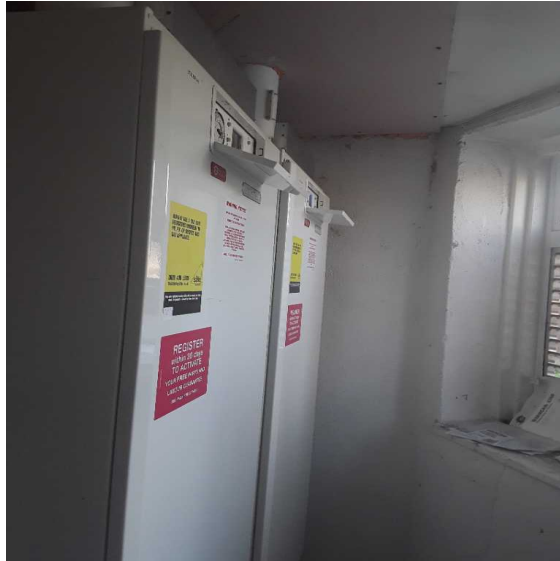
Code:	IW00311640	Site:	414007 Bradmore Green Library
Element:	FM-06 Mechanical Services	Building:	414007/1
Subelement:	FM/06/6 Boiler Systems	Room:	6
Item:	FM/06/38 Gas Fired Boiler	Cost:	£5000.00
Condition:	B Satisfactory Condition	Remedy:	Replace boiler Target year: 2023-24
Priority:	4 Desirable Works - next 3 - 5 years	Defect:	The boiler is in general a fair condition and is estimated to be 20 years old

Comments: Please consult a boiler manufacturer prior to replacing
