Caterham Drive Flood Investigation Report – 7th June 2016

*Final Version
January 2017*

Reference
Caterham Drive Flood Investigation Report

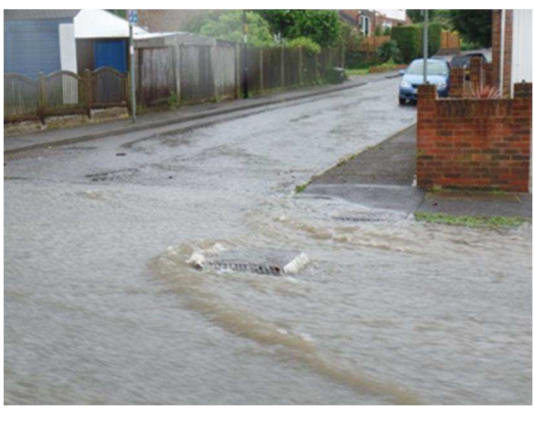
Surcharging manhole on Caterham Drive
02

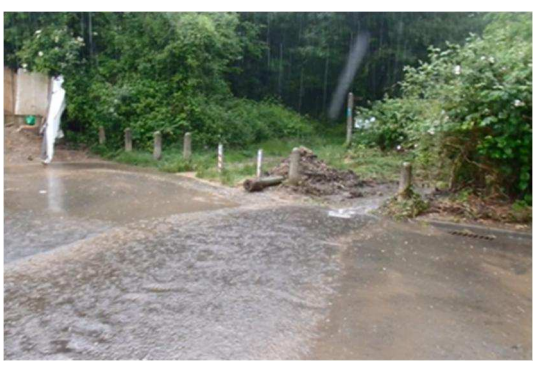
Ground at end of road was dug out to allow surface water to continue its route into the neighbouring woodland known as 'Dollypers Hill'

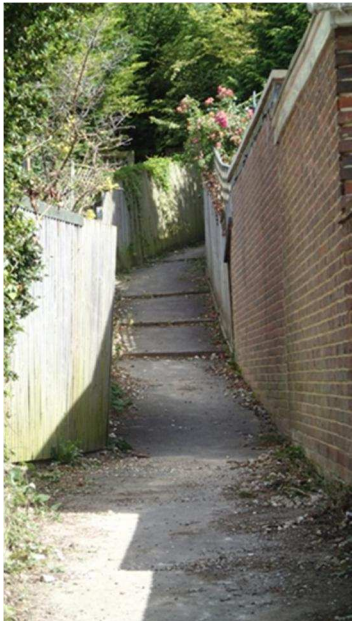
<p>Pathway leading onto Caterham Drive was recently tarmaced adding to the area of impermeable surface. The debris visible on the path was deposited during the 7th June 2016 flood</p>
06	 	<p>Evidence of surface water flowing onto Stites Hill Road, adjacent to City of London Park</p>

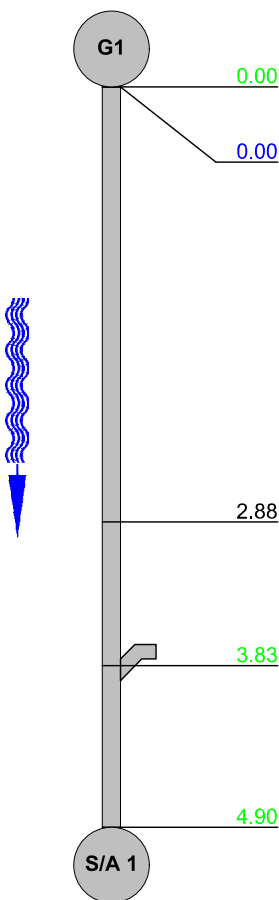
0.00	GY	Start node type, gully, reference number : G1	(Constr) 0
	0.00	WL	Water level, 5% of the vertical dimension	(Serv) 0
	2.88	REM	General remark Remarks: MAIN REACHED AT THIS POINT. SURVEY CONTINUES DOWN TO S/A 1	(Misc) 0
	3.83	JN	Junction, at 10 o'clock, diameter 150mm Remarks: FROM G2	(Constr) 0
	4.90	MHF	Finish node type, manhole reference number: S/A 1	(Constr) 0
Depth: 0

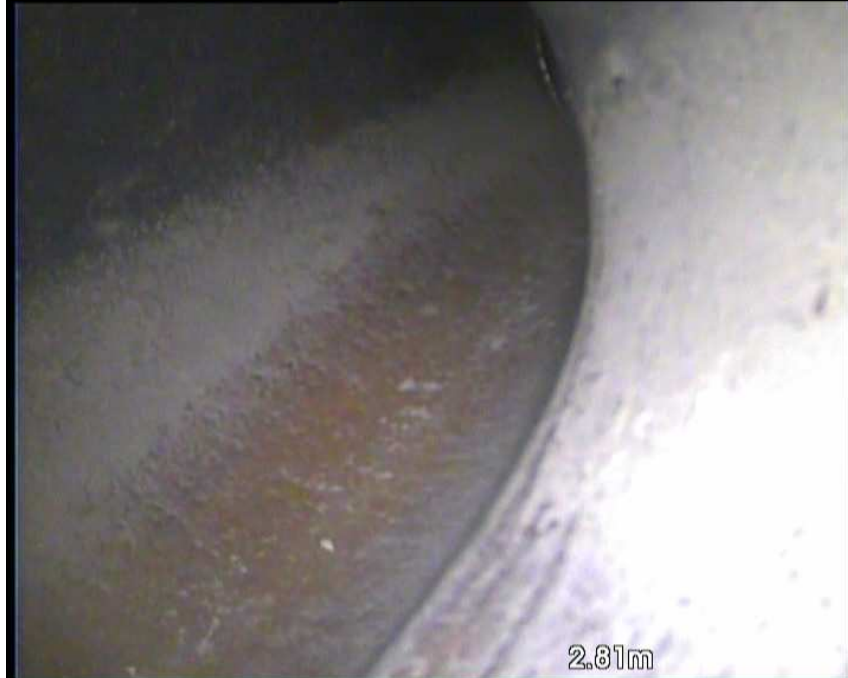
Place : CROYDON	Road : CATERHAM DRIVE	Date : 04/07/2016	Section number : 1	PLR Suffix : X
---------------------------	---------------------------------	-----------------------------	------------------------------	--------------------------

Photo: 0000001.jpg, 00:00:00
2.88m, General remark

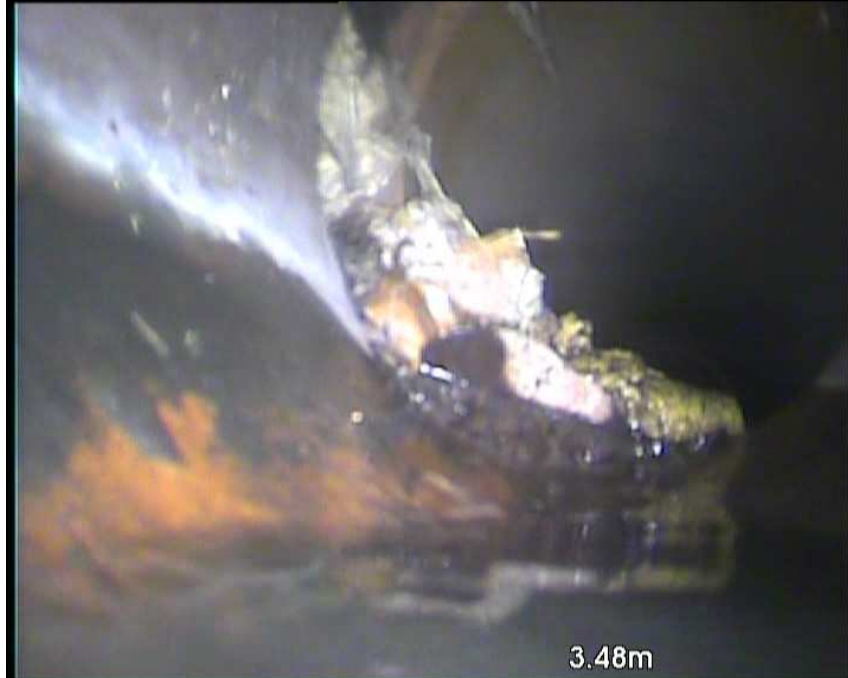
Section number :
2

Photo: 0000002.jpg, 00:00:00
3.48m, Broken pipe at joint, from 6 to 12 o'clock

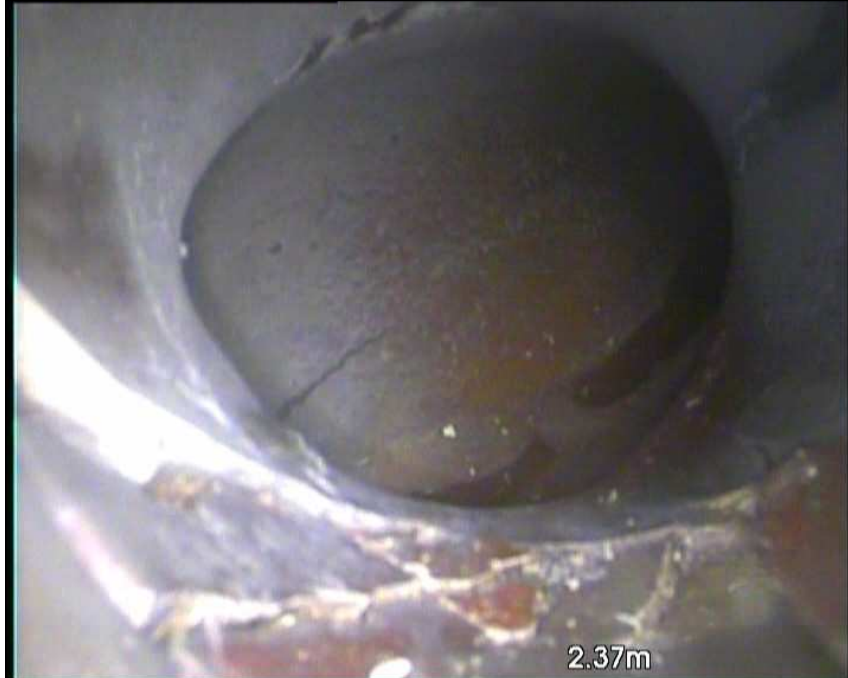
Place : CROYDON	Road : CATERHAM DRIVE	Date : 04/07/2016	Section number : 3	PLR Suffix : X
---------------------------	---------------------------------	-----------------------------	------------------------------	--------------------------

Photo: 0000003.jpg, 00:00:00
2.37m, Fracture, multiple, from 7 to 9 o'clock

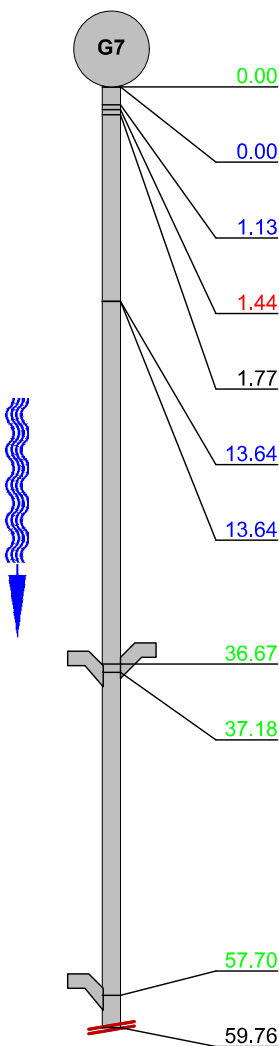
0.00	GY	Start node type, gully, reference number : G7	(Constr) 0
	0.00	WL	Water level, 5% of the vertical dimension	(Serv) 0

1.13	LR	Line deviates right	(Serv) 0
	1.44	JDM	Joint displaced, medium	(Struct) 1
	1.77	REM	General remark Remarks: MAIN REACHED AT THIS POINT. SURVEY CONTINUES DOWN TO S/A 3	(Misc) 0

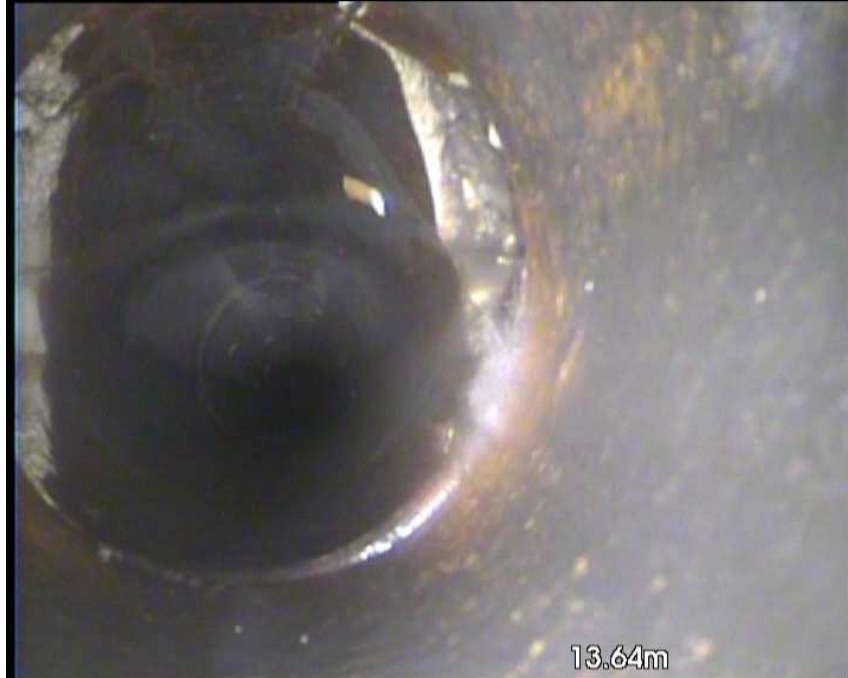
Section number :
6

Photo: 0000004.jpg, 00:00:00

13.64m, Attached deposits, encrustation, from 1 to 3 o'clock, 5% cross-sectional area loss

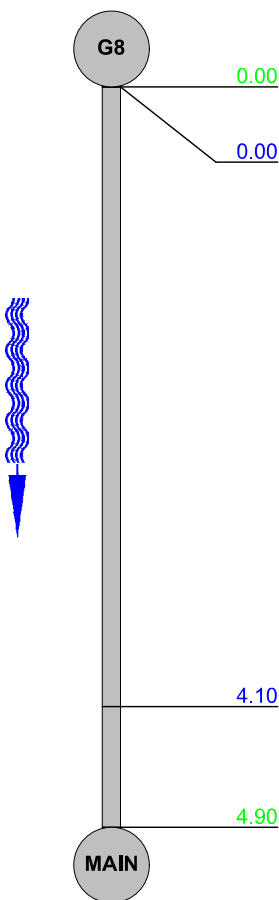
0.00	GY	Start node type, gully, reference number : G8	(Constr) 0
	0.00	WL	Water level, 5% of the vertical dimension	(Serv) 0
	4.10	LL	Line deviates left	(Serv) 0
	4.90	GYF	Finish node type, gully reference number: MAIN	(Constr) 0
Depth: 0

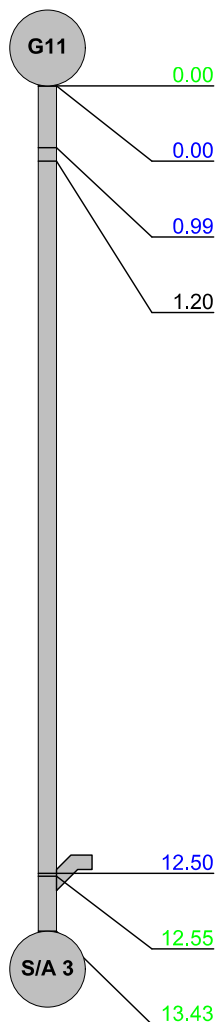
G11	GY	Start node type, gully, reference number : G11 (Constr) 0
	0.00	WL	Water level, 5% of the vertical dimension (Serv) 0	
	0.99	LD	Line deviates down (Serv) 0	
	1.20	REM	General remark Remarks: MAIN REACHED AT THIS POINT. SURVEY CONTINUES DOWN TO S/A 3. (Misc) 0	
	12.50	RFJ	Roots, fine at joint (Serv) 2	
	12.55	JN	Junction, at 10 o'clock, diameter 150mm Remarks: PROBABLY FROM G12 (Constr) 0	
	13.43	MHF	Finish node type, manhole reference number: S/A 3 (Constr) 0

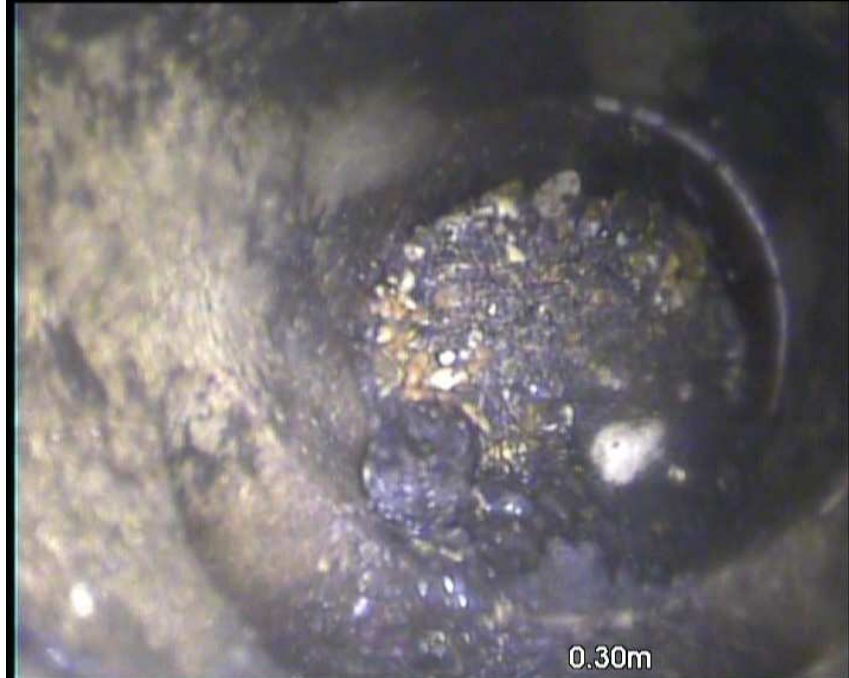
Place : CROYDON	Road : CATERHAM DRIVE	Date : 04/07/2016	Section number : 11	PLR Suffix : X
---------------------------	---------------------------------	-----------------------------	-------------------------------	--------------------------

Photo: 0000006.jpg, 00:00:00
0.5m, Collapsed drain/sewer
