Croydon Flood Investigation Report – 24th August 2015

*Final Version
October 2016*

Reference
Croydon Flood Investigation Report – August 2015

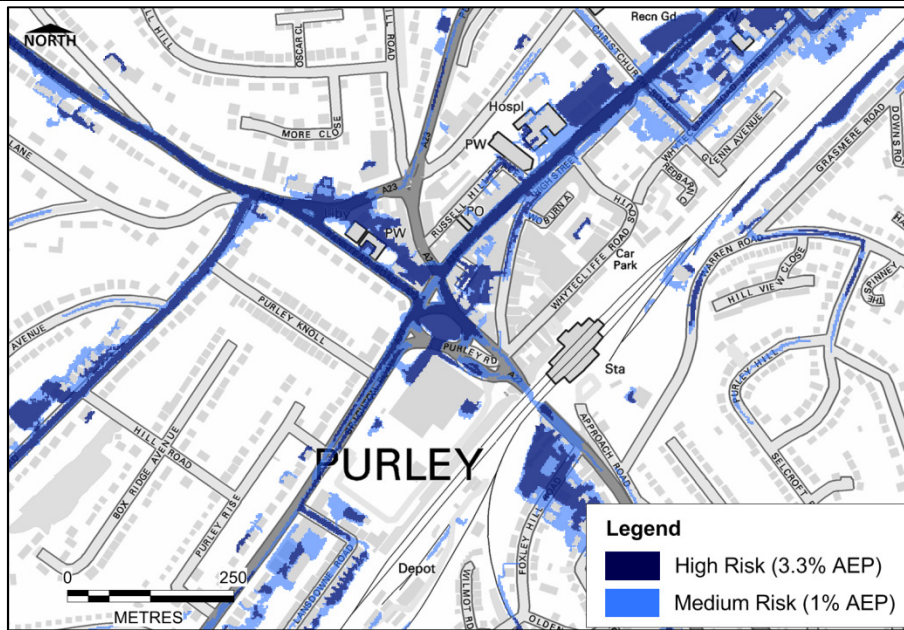
Figure 4-1 – Modelled surface water flood risk in the Purley Cross area according to the ‘Risk of flooding from surface water’ mapping (Environment Agency)

This area has been identified as a Critical Drainage Area (CDA_040 Purley Cross) in the SWMP. National surface water flood risk mapping produced by the Environment Agency (Risk of flooding from surface water) identifies Purley Cross to be highly susceptible to surface water flooding due to its location within a topographic depression. Much of the northern half of the roundabout, the central pedestrian area and pedestrian underpass are shown to be at risk from a 1 in 30 year (3.33% annual exceedance probability (AEP)) surface water flooding event occurring in any given year. The approaching roads including the A23 Brighton Road from the south west, A22 Godstone Road to the south east and the A235 Brighton Road to the north are also shown to be at risk from a 1 in 30 year (3.33% AEP) surface water flooding event occurring in any given year.

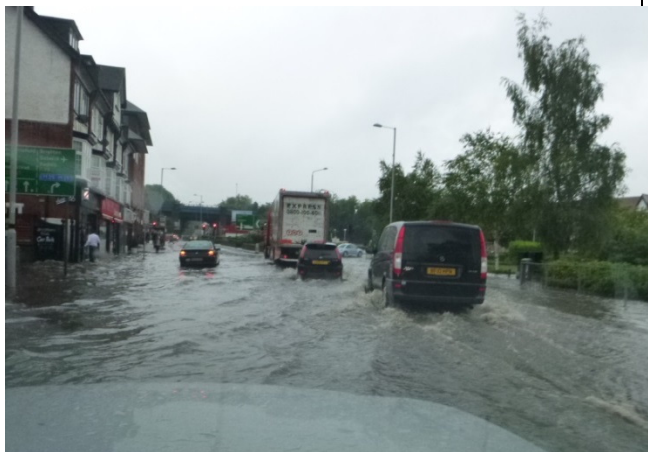
Heavy rainfall in the south of the Borough overwhelmed and exceeded the capacity of the highway drainage network at the Purley Cross roundabout, causing the drainage system to surcharge, lifting manhole covers and leading to the rapid onset of surface water flooding across the roundabout. The deepest flooding was experienced in the pedestrian underpass beneath the roundabout (Figure 4-2 and Figure 4-3), where it was reported to be approximately 1 foot (0.3m) below the underside of the bridge (2.7m clearance), an approximate depth of 2.4m. This flooding was reportedly exacerbated by failure of the pumping system in the underpass.

Flooding was also reported on the surrounding road network, including the northern (Figure 4-2) and western (Figure 4-3) sections of the roundabout, causing travel disruption.

Figure 4-2 - Northern section of roundabout, looking south east towards Purley Road (source: Croydon Council)

The high intensity rainfall in an urbanised area combined with asset failure is identified as the flood source at this location. The impermeable road surfaces and building rooftops within the catchment directed surface water towards the highway drainage network. Due to the extreme nature of the rainfall event (estimated return period of 1 in 38 annual probability of this rainfall event occurring in any given year), the volume of surface water exceeded the hydraulic capacity of road gullies and drain gratings (designed for a 1 in 30 year annual probability rainfall event), and as a result, surface water continued to flow overland. The increase in the volume of surface water entering the drainage network further downstream exceeded the network capacity causing the sewer network to back up, surcharge and ultimately flood to significant depths, particularly in low lying areas. Furthermore, the failure of the pump in the pedestrian underpass meant water was unable to drain away from this low point.

- Drainage engineers were in attendance at Purley Cross actively dealing with the removal of flood water by tanker, and the repair of the pumps.
- TfL has advised that a scheme is programmed to start in 2016/17 to make changes to the Purley Oaks underpass pump, including the relocation of the control cabinet to a higher level to prevent it from being submerged by flood water in the future.

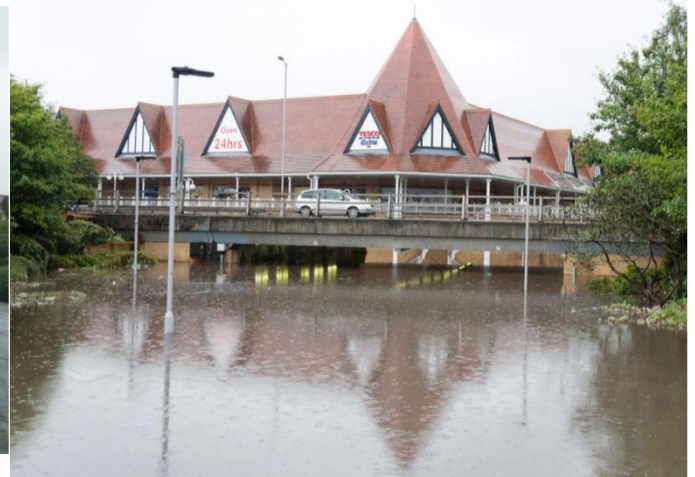
Figure 4-3 - Purley Oak underpass (source: Evening Standard)

Specifically at Purley Cross, the drainage network upstream and downstream of the pump station does not have sufficient capacity to manage the volume of water encountered. In addition, the extreme nature of the rainfall event had a knock on effect leading to the failure of the TfL operated pumps at the pedestrian underpass due to flooding of the control box, further exacerbating the flooding at this location.

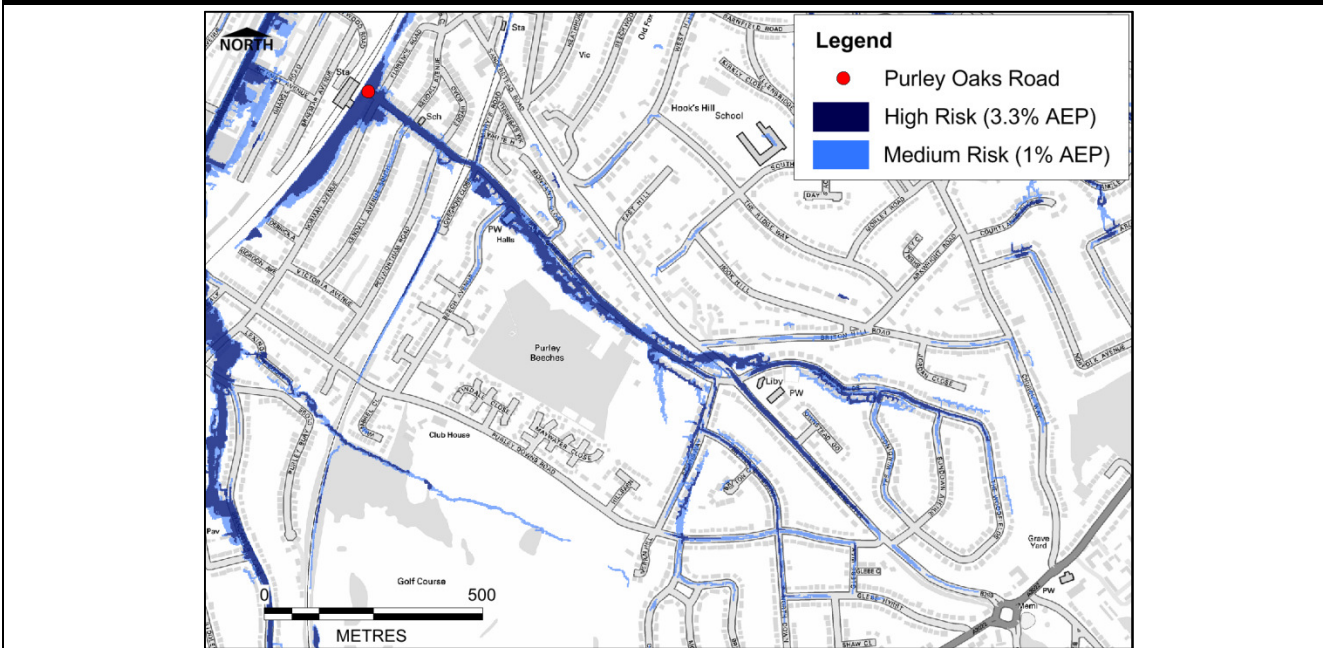
Figure 4-4 – Modelled surface water flood risk in the catchment above Purley Oaks Road according to the ‘Risk of flooding from surface water’ mapping (Environment Agency)

The surface water flood risk map (Figure 4-4) indicates that the road and commercial properties (Figure 4-5 and Figure 4-6) are located in a topographic depression (approx. 70 mAOD) situated at the bottom of a surface water catchment. The

surface water catchment is shown to extend from the uphill areas to the south east along Purley Oaks Road, Farm Fields, Sanderstead Hill and Downsway up to approximately 150 mAOD.

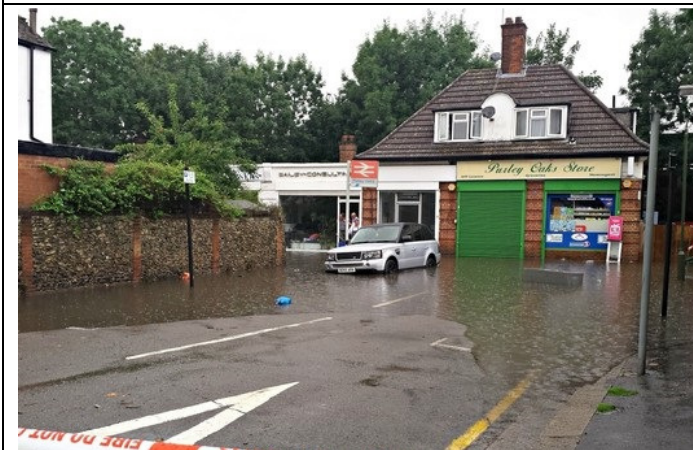
Figure 4-5 – Purley Oaks Road (source: Croydon Advertiser)

The high intensity rainfall in an urbanised area is identified as the flood source. The impermeable road surfaces and building rooftops within the catchment directed surface water towards the highway drainage network. Surveys undertaken of the drainage network along Purley Oaks Road indicate that the soakaway situated in the road outside of the commercial properties has five inflows consisting of;

The surveys also found there to be only one outflow from the soakaway, consisting of a single 150mm concrete pipe, 2m in length, draining to a combined sewer manhole. The small diameter outflow is likely to have created a 'bottleneck', and in combination with the extreme nature of the rainfall event, the volume of surface water is likely to have caused the highway drainage network to back up, surcharge and flood.

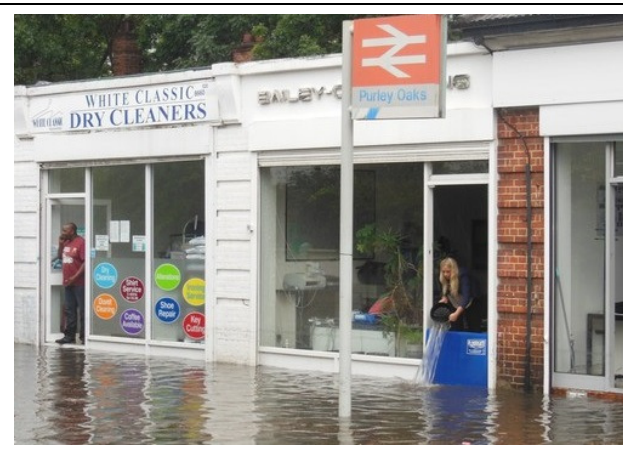
Figure 4-6 – Flooded commercial properties on Purley Oaks Road (source: Croydon Advertiser)

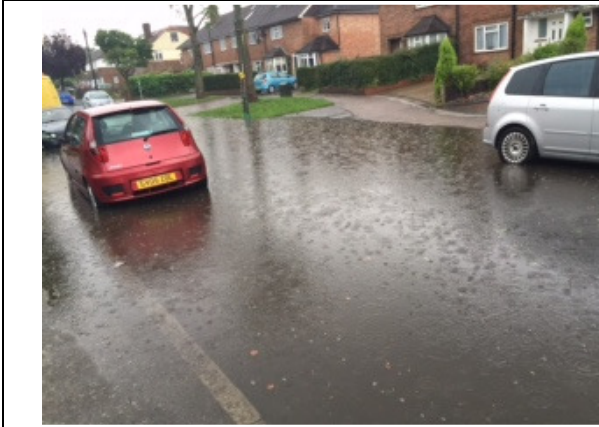
Figure 4-9 - Harewood Gardens, South Croydon (source: Croydon Council)

The locations of these flood events correlate closely with areas identified as being at between High and Medium risk of surface water flooding (between a 3.3% AEP and 1% AEP) in the surface water flood risk map produced by the Environment Agency. Whilst most of Bensham Manor Road is mapped at very low risk of surface water flooding, the reported incident coincides with a small area of mapped risk, likely to be associated with a low point in the road. Flooding was reportedly exacerbated by blocked gullies.

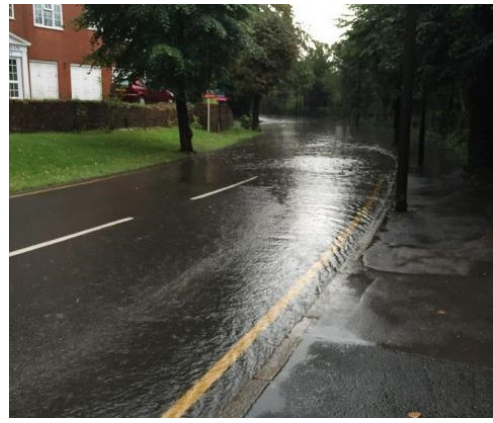
Figure 4-10 – Warren Road, Purley (source: Croydon Guardian)
