Caterham Drive Flood Investigation Report – 7th June 2016

*Final Version
January 2017*

Reference
Caterham Drive Flood Investigation Report

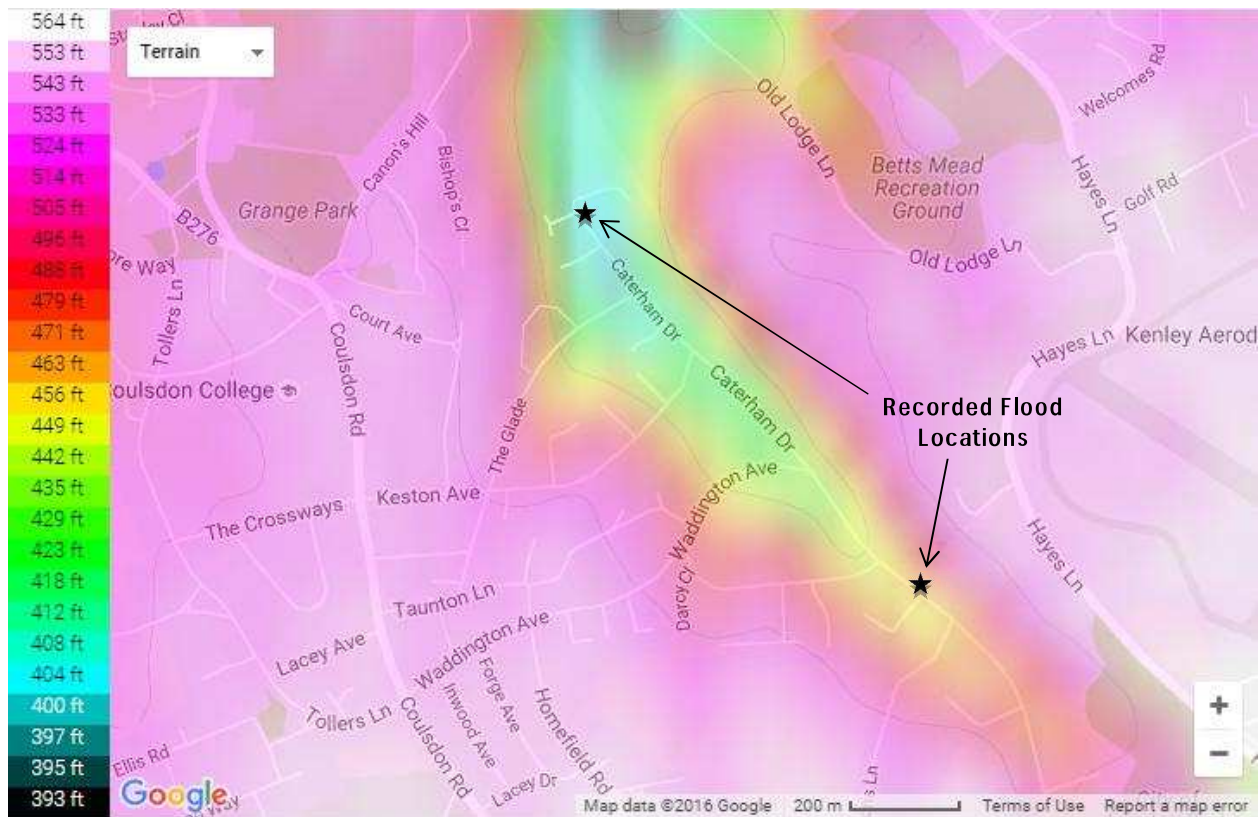
Figure 2-1 Topographic Map of Coulsdon¹¹

The topographic map of the area shown in Figure 2-1 demonstrates that the natural topography of Caterham Drive promotes accumulation of surface water and directs surface water runoff along Caterham Drive from the southeast to the northwest as well as from the hills to the east and west. The properties flooded on 7th June 2016 are located in this topographic low where surface waters form prominent flow paths.

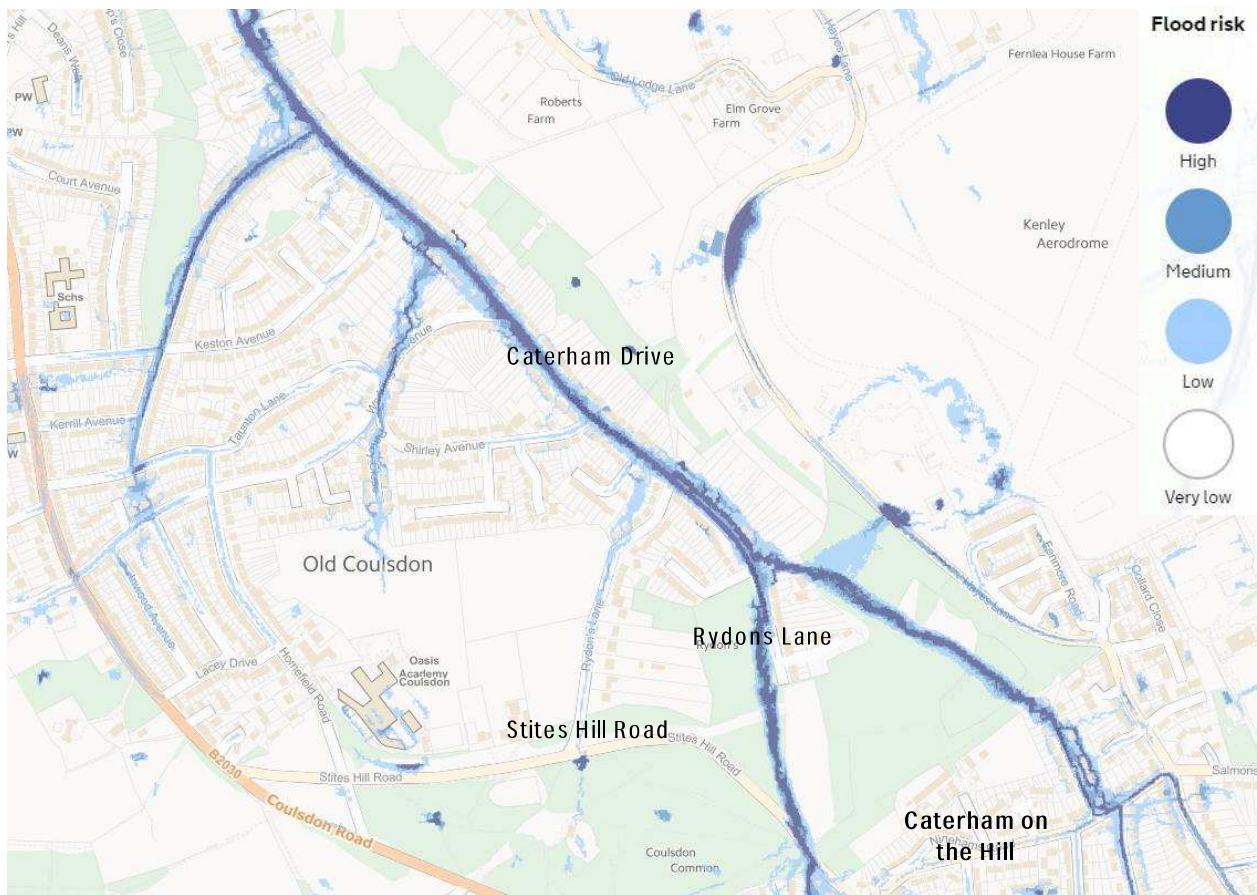
Figure 2-2 Environment Agency flood map for Risk of Flooding from Surface Water¹²

The Risk of Surface Water Flood Map illustrates a surface water flow path flowing in a north westerly direction, originating in the vicinity of Caterham-on-the-Hill flowing onto Caterham Drive. EA mapping identifies roads and properties within the vicinity of this flow path to be at risk of surface water flooding with an annual probability of greater than 3.3% ('High' 1 in 30 year return period). This is likely to be caused by urban runoff, with contributions from rural surfaces depending on the severity of the event and antecedent catchment conditions.

Figure 2-2 displays the Environment Agency's RoFSW map, which demonstrates a major flow pathway from Caterham on the Hill north to Caterham Drive via Coulsdon Common. Photographic and video evidence of the 7th June 2016 event provided by the council reveals surface water runoff flowing onto Caterham Drive from Rydon's Lane and Stites Hill Road (Table 4); providing evidence for the flow path identified on the Environment Agency RoFSW map. However, to confirm the source of this additional surface water further investigation and detailed modelling of the area is required.

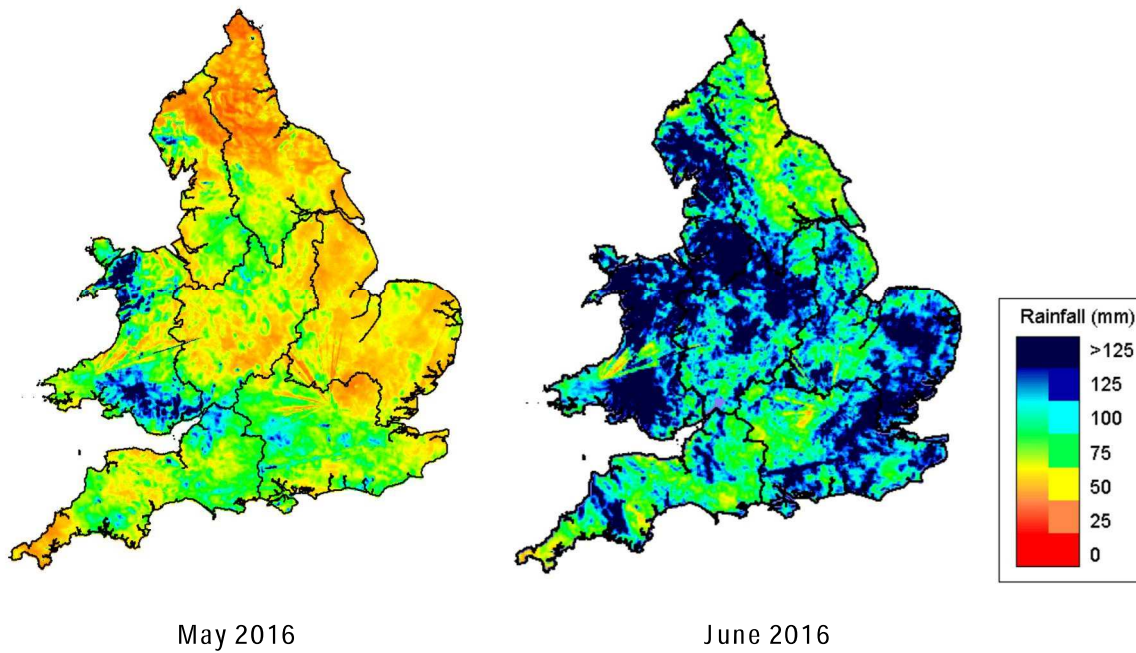
Figure 3-1 Extract from the Environment Agency Monthly Water Situation Report: June 2016

According to the Environment Agency Monthly Water Situation Report¹³, the South London catchment rainfall total for June 2016 was the wettest month on record for this area, since records began in 1981¹⁴. Kent and the South of London received 198% of the long-term average rainfall for June. The intense storm that caused the flooding at Caterham Drive occurred on 7th June 2016 between 12:30 and 15:30. A number of local weather stations recorded over a month's worth of rainfall during this period as summarised in Table 3-2.
