Limited Building Survey Report

**Broad Green Library
89 Canterbury Road
Croydon
London
CR0 3HA**

**Job No: 31057
Date: January 2019**

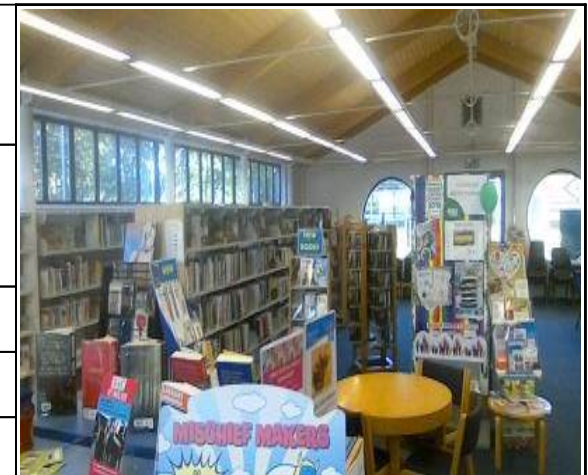
Inspection Number:	1	Intrusive Area – Yes or No:	No
Item:	Detail:	Item:	Detail:
Material Assessment		Priority Risk Assessment	
Building:	Block A / Library	Location:	N/A
Location:	Ground / Library 1	Accessibility:	N/A
Sample Number:	Visual	Extent / Amount:	N/A
Description:	No suspect materials visually found	Normal Occupant Activity:	N/A
Position:		Secondary Occupant Activity:	N/A
Extent:		Number of Occupants:	N/A
Product Type:		Frequency of Use of Area:	N/A
Damage & Deterioration:	N/A	Average Time Area in Use:	N/A
Surface Treatment:	N/A	Maintenance Type:	N/A
Asbestos Type:		Frequency of Maintenance Activity:	N/A
Material Score:	0	Priority Score:	0

Room Comments:	Wood ceiling,solid walls and floor,wood beams on metal pillars,metal windows,wood and metal doors
Sample Comments:	N/A
Total Assessment Score:	0
Risk Assessment Category:	N/A
Recommendation:	Not applicable

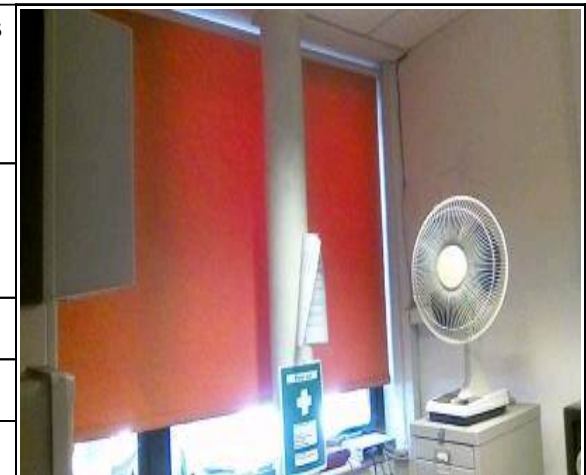
Inspection Number:	2	Intrusive Area – Yes or No:	No
Item:	Detail:	Item:	Detail:
Material Assessment		Priority Risk Assessment	
Building:	Block A / Library	Location:	N/A
Location:	Ground / Office 2	Accessibility:	N/A
Sample Number:	Visual	Extent / Amount:	N/A
Description:	No suspect materials visually found	Normal Occupant Activity:	N/A
Position:		Secondary Occupant Activity:	N/A
Extent:		Number of Occupants:	N/A
Product Type:		Frequency of Use of Area:	N/A
Damage & Deterioration:	N/A	Average Time Area in Use:	N/A
Surface Treatment:	N/A	Maintenance Type:	N/A
Asbestos Type:		Frequency of Maintenance Activity:	N/A
Material Score:	0	Priority Score:	0

Room Comments:	Wood ceiling above mmmf Suspended ceiling tiles,solid walls and floor,metal pillar,metal window with wood sill,wood door and frame
Sample Comments:	N/A
Total Assessment Score:	0
Risk Assessment Category:	N/A
Recommendation:	Not applicable

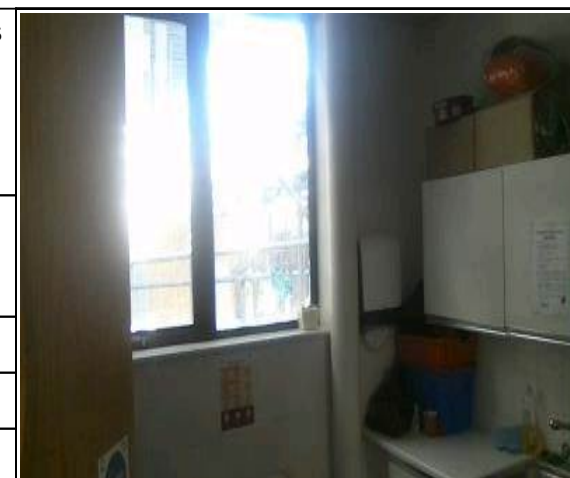
Inspection Number:	3	Intrusive Area – Yes or No:	No
Item:	Detail:	Item:	Detail:
Material Assessment		Priority Risk Assessment	
Building:	Block A / Library	Location:	N/A
Location:	Ground / Kitchen 3	Accessibility:	N/A
Sample Number:	Visual	Extent / Amount:	N/A
Description:	No suspect materials visually found	Normal Occupant Activity:	N/A
Position:		Secondary Occupant Activity:	N/A
Extent:		Number of Occupants:	N/A
Product Type:		Frequency of Use of Area:	N/A
Damage & Deterioration:	N/A	Average Time Area in Use:	N/A
Surface Treatment:	N/A	Maintenance Type:	N/A
Asbestos Type:		Frequency of Maintenance Activity:	N/A
Material Score:	0	Priority Score:	0

Room Comments:	Wood ceiling above mmmf Suspended ceiling tiles,solid walls and floor,metal pillar,metal window with wood sill,wood door and frame,Baxi boiler with metal flue,wood and laminate kitchen units
Sample Comments:	N/A
Total Assessment Score:	0
Risk Assessment Category:	N/A
Recommendation:	Not applicable

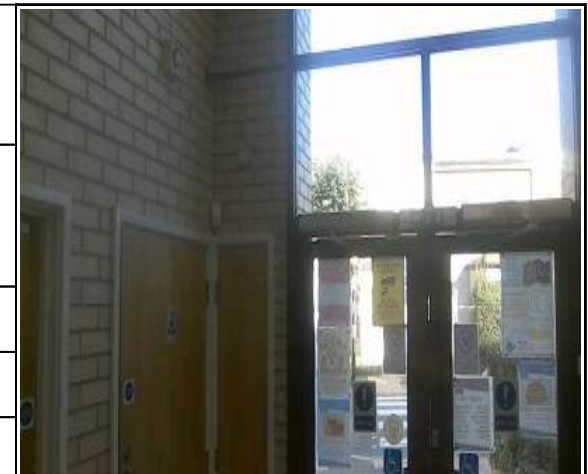
Inspection Number:	4	Intrusive Area – Yes or No:	No
Item:	Detail:	Item:	Detail:
Material Assessment		Priority Risk Assessment	
Building:	Block A / Library	Location:	N/A
Location:	Ground / Lobby 4	Accessibility:	N/A
Sample Number:	Visual	Extent / Amount:	N/A
Description:	No suspect materials visually found	Normal Occupant Activity:	N/A
Position:		Secondary Occupant Activity:	N/A
Extent:		Number of Occupants:	N/A
Product Type:		Frequency of Use of Area:	N/A
Damage & Deterioration:	N/A	Average Time Area in Use:	N/A
Surface Treatment:	N/A	Maintenance Type:	N/A
Asbestos Type:		Frequency of Maintenance Activity:	N/A
Material Score:	0	Priority Score:	0

Room Comments:	Wood ceiling with wood skylights, solid walls and floor, metal doors and frames
Sample Comments:	N/A
Total Assessment Score:	0
Risk Assessment Category:	N/A
Recommendation:	Not applicable

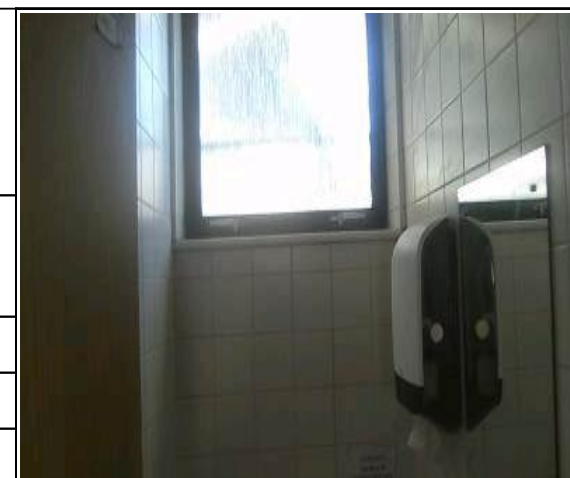
Inspection Number:	5	Intrusive Area – Yes or No:	No
Item:	Detail:	Item:	Detail:
Material Assessment		Priority Risk Assessment	
Building:	Block A / Library	Location:	N/A
Location:	Ground / Toilet 5	Accessibility:	N/A
Sample Number:	Visual	Extent / Amount:	N/A
Description:	No suspect materials visually found	Normal Occupant Activity:	N/A
Position:		Secondary Occupant Activity:	N/A
Extent:		Number of Occupants:	N/A
Product Type:		Frequency of Use of Area:	N/A
Damage & Deterioration:	N/A	Average Time Area in Use:	N/A
Surface Treatment:	N/A	Maintenance Type:	N/A
Asbestos Type:		Frequency of Maintenance Activity:	N/A
Material Score:	0	Priority Score:	0

Room Comments:	Wood ceiling with mmmf Suspended ceiling tiles,solid walls and floor,modern plastic floor covering,metal window with wood sill,glazed Wc cistern and sink,wood door and frame,wood boxing to wall
Sample Comments:	N/A
Total Assessment Score:	0
Risk Assessment Category:	N/A
Recommendation:	Not applicable

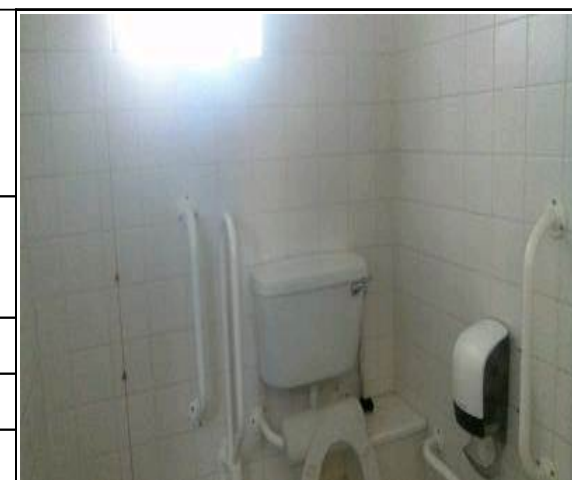
Inspection Number:	6	Intrusive Area – Yes or No:	No
Item:	Detail:	Item:	Detail:
Material Assessment		Priority Risk Assessment	
Building:	Block A / Library	Location:	N/A
Location:	Ground / Toilet 6	Accessibility:	N/A
Sample Number:	Visual	Extent / Amount:	N/A
Description:	No suspect materials visually found	Normal Occupant Activity:	N/A
Position:		Secondary Occupant Activity:	N/A
Extent:		Number of Occupants:	N/A
Product Type:		Frequency of Use of Area:	N/A
Damage & Deterioration:	N/A	Average Time Area in Use:	N/A
Surface Treatment:	N/A	Maintenance Type:	N/A
Asbestos Type:		Frequency of Maintenance Activity:	N/A
Material Score:	0	Priority Score:	0

Room Comments:	Wood ceiling with mmmf Suspended ceiling tiles,solid walls and floor,modern plastic floor covering,metal window with wood sill,glazed Wc cistern and sink,wood door and frame,wood boxing to wall
Sample Comments:	N/A
Total Assessment Score:	0
Risk Assessment Category:	N/A
Recommendation:	Not applicable

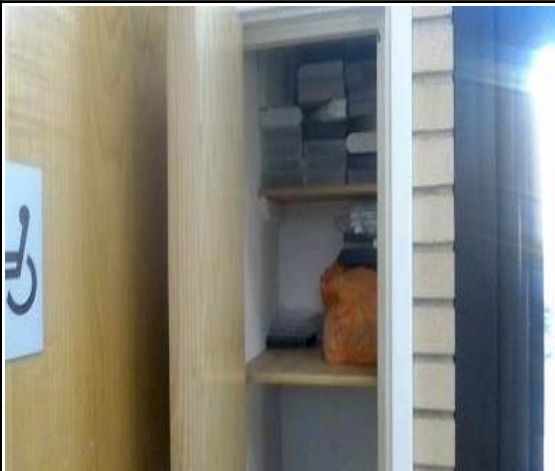
Inspection Number:	7	Intrusive Area – Yes or No:	No
Item:	Detail:	Item:	Detail:
Material Assessment		Priority Risk Assessment	
Building:	Block A / Library	Location:	N/A
Location:	Ground / Cupboard 7	Accessibility:	N/A
Sample Number:	Visual	Extent / Amount:	N/A
Description:	No suspect materials visually found	Normal Occupant Activity:	N/A
Position:		Secondary Occupant Activity:	N/A
Extent:		Number of Occupants:	N/A
Product Type:		Frequency of Use of Area:	N/A
Damage & Deterioration:	N/A	Average Time Area in Use:	N/A
Surface Treatment:	N/A	Maintenance Type:	N/A
Asbestos Type:		Frequency of Maintenance Activity:	N/A
Material Score:	0	Priority Score:	0

Room Comments:	Plasterboard ceiling, solid and plasterboard walls, solid floor, wood door and frame

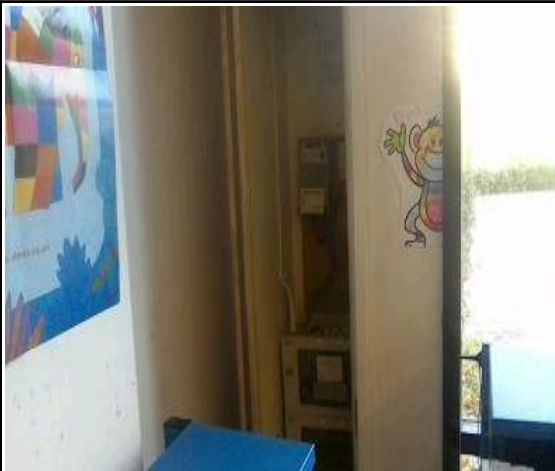
Inspection Number:	8	Intrusive Area – Yes or No:	No
Item:	Detail:	Item:	Detail:
Material Assessment		Priority Risk Assessment	
Building:	Block A / Library	Location:	N/A
Location:	Ground / Cupboard 8	Accessibility:	N/A
Sample Number:	Visual	Extent / Amount:	N/A
Description:	No suspect materials visually found	Normal Occupant Activity:	N/A
Position:		Secondary Occupant Activity:	N/A
Extent:		Number of Occupants:	N/A
Product Type:		Frequency of Use of Area:	N/A
Damage & Deterioration:	N/A	Average Time Area in Use:	N/A
Surface Treatment:	N/A	Maintenance Type:	N/A
Asbestos Type:		Frequency of Maintenance Activity:	N/A
Material Score:	0	Priority Score:	0

Room Comments:	Plasterboard ceiling, solid and plasterboard walls, solid floor, wood door and frame, modern electrics

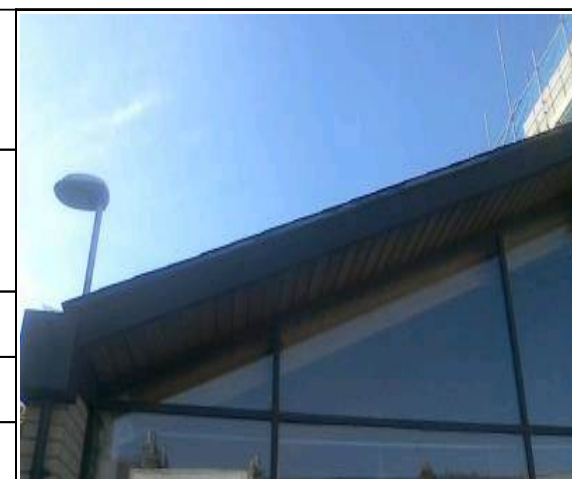
Inspection Number:	9	Intrusive Area – Yes or No:	No
Item:	Detail:	Item:	Detail:
Material Assessment		Priority Risk Assessment	
Building:	Block A / Library	Location:	N/A
Location:	External / External 0	Accessibility:	N/A
Sample Number:	DJ004042	Extent / Amount:	N/A
Description:	Roof tiles	Normal Occupant Activity:	N/A
Position:	Roof	Secondary Occupant Activity:	N/A
Extent:	Throughout	Number of Occupants:	N/A
Product Type:	Reinforced Composite	Frequency of Use of Area:	N/A
Damage & Deterioration:	Low Damage	Average Time Area in Use:	N/A
Surface Treatment:	Composite materials containing asbestos	Maintenance Type:	N/A
Asbestos Type:	No Asbestos Detected	Frequency of Maintenance Activity:	N/A
Material Score:	0	Priority Score:	0

Room Comments:	Composite tiles to pitched roof, metal rainwater goods, wood fascia boards, brick walls, metal windows and doors
Sample Comments:	N/A
Total Assessment Score:	0
Risk Assessment Category:	N/A
Recommendation:	Not applicable
