CONDITION SURVEY SUMMARY

SHIRLEY LIBRARY

Wickham Road / Hartland Way, Shirley,
Croydon. CR0 8BH.

Shirley Library Condition Survey

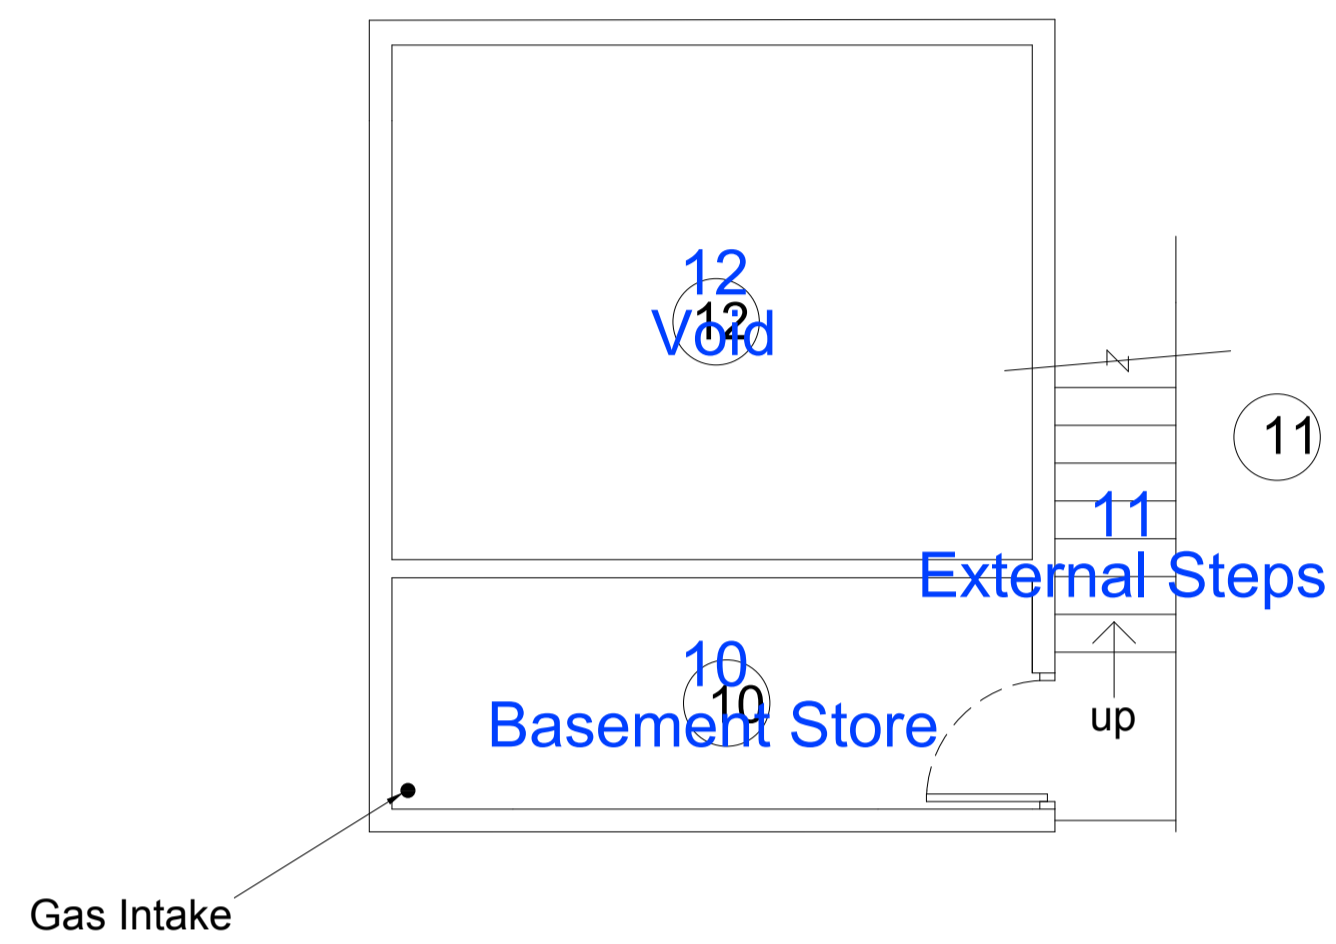
Basement Plan

Block A
Basement

Property: Shirley Library
Title: Basement

Area Information	Job: S5382
Total Site Area:	Scale: 1:50@A1 1:100@A3
Gross External Area: 292.4	Date: 12/10/2012
Gross Internal Area: 279.1	Survey: N/A
Total Room Area: 270.9	Drawn: CC
Net Internal Area: 243.0	Checked: ARB
Filename: Shirley Library.dwg	
Drawing No: 414011
